# ASP Safety Alert

Alert Number: SA01\_19

Subject: ABB Safelink RMU – Missing earth bond

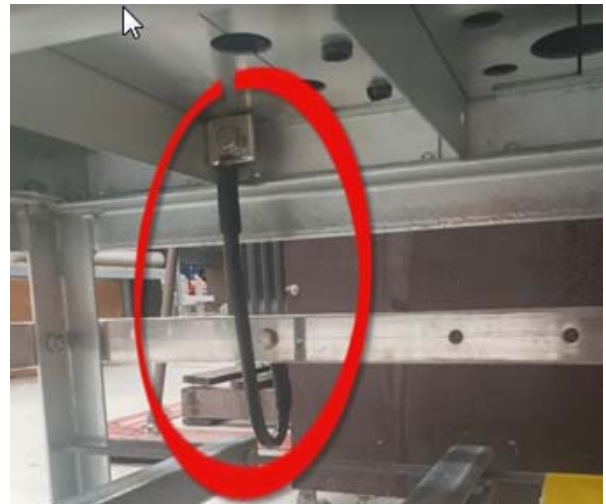
70mm Cu cable (Chamber installation)

A number of Safelink RMU's have been identified to be missing (not installed) an earth bond, which connects the switch unit to the earth bar located on the support stand.

The body of the switchgear is connected to earth via the earthed frame, however, the earth switches and the switching tank are not connected to earth through a proven low impedance connection as per design requirements unless the bond is installed correctly.

If the bond is not installed correctly, hazardous situations may arise during switching and fault conditions. Additionally, the functionality of earth switches within RMU's with missing earth bonds cannot be guaranteed.

If the earth bond between the switching tank and the support stand earth bar is found to be missing, a 70mm Cu black PVC cable (chamber substations) or 50x6mm Cu bar (kiosk substations) must be installed.
