# ASP General Information

**Alert Number: GI02\_21**

**Subject: Substation Cable Termination Issues & Defects**

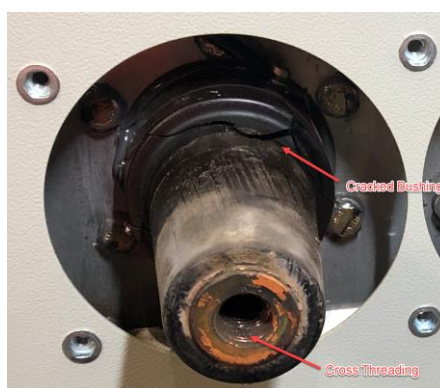
Investigations on recently installed distribution assets where bushing failures have occurred have exhibited that, in most cases, the cause has been related to the mechanical stress applied on Low Voltage & High Voltage cable terminations.

There is evidence that suggest that in some cases the incorrect torque has been applied to the bolted connections during installation. In other cases, it has been found that the associated cable has not been adequately supported.

Cracked 11kV Switchgear Bushing - Lucy VRN6a

Stressed and cracked bushings on Distribution Switchgear and Transformers result in oil and SF6 gas leaks. Not only does this incur maintenance costs while substantially reducing the life of the asset, there can also be significant environmental impact due to leakage.

The respective asset manufacturer installation guidelines and manuals clearly illustrate the minimum requirements for the cable installation and specify the correct steps for cable termination. It is critical to utilise the specified size bolts and correct technique to avoid cross threading.

Correct tools for terminations must be utilised with a correct torque setting for cable bushing terminations. The consequence of not adhering to the correct torque setting potentially applies an unknown stress on the terminations which could result in bushing seal dislodging or a loose connection.

As part of the installation ensure all cables are laid and supported in such a way there is no stress on equipment bushings and cable cleats and glands are utilised.

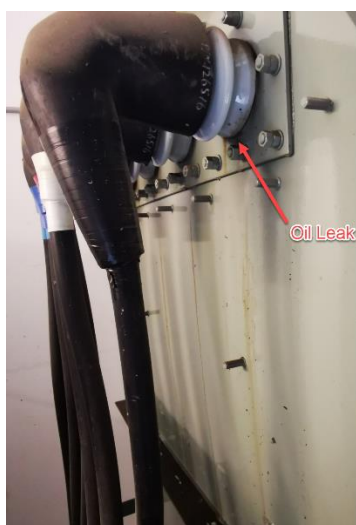
Disturbed LV Bushing Gasket - Schneider 100kVA Tx
