ASP Safety Alert

Alert Number: SA12_17

Subject: Incorrect Service Cable Markings

25 September 2017

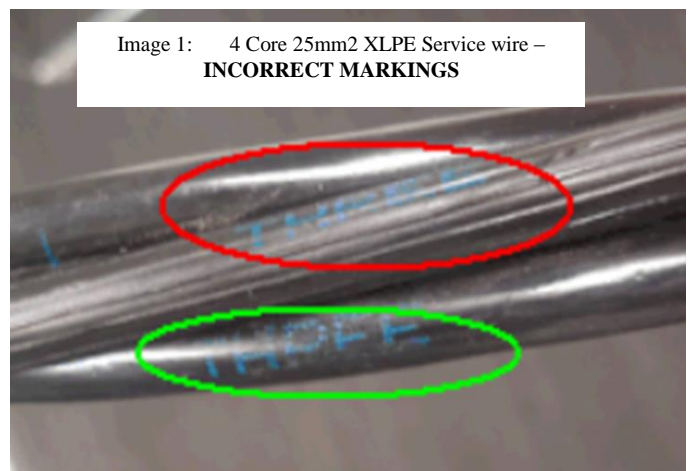
While undertaking service wire replacement works, a member of the workgroup noticed that the sheaths on a drum of 4 Core 25mm² XLPE covered aluminium service cable, had been incorrectly marked. It was noted that "THREE" had been printed on both the "C" Phase conductor (3 ribs) as well as the Neutral conductor (fully ribbed). The issue is believed to be isolated to 'Prysmian' branded service cables only. Refer image 1.

No incident resulted. Pre-energisation procedures identified potential phasing issues and the ribs on the sheaths were still able to be used to identify the correct conductors.

The remaining cable was rolled off the drum, quarantined and Ausgrid is currently investigating the labelling non-compliance with the manufacturer.

ASPs are requested to check their company's stock and quarantine any affected cable as required.
