ASP Safety Alert

Subject: Leveling rod failure on GMJ EWP

3 February 2025

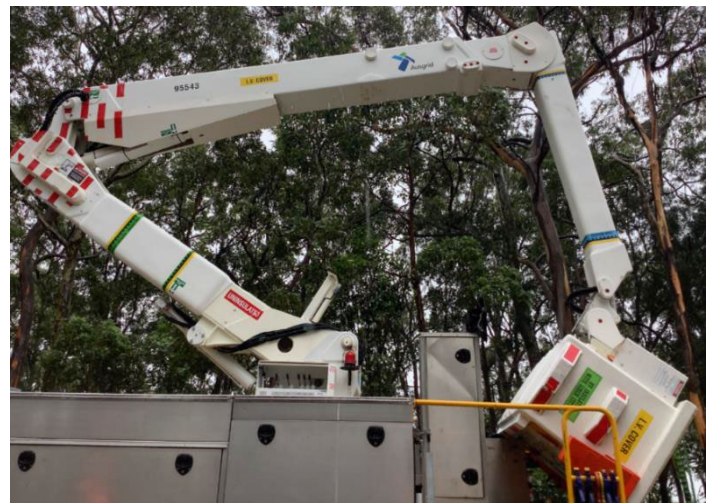
In the process of stowing the basket of a GMJ EWP, it is suspected a leveling rod has failed resulting in two Ausgrid workers being ejected from the EWP basket. Both workers were wearing harnesses and were attached to the basket at the time of the incident.

Both workers received non-life threatening injuries as a result of the incident and were taken to hospital for further assessment and treatment.

Ausgrid's fleet management have identified an initial 28 GMJ EWPs to be temporarily removed from service as a precaution until further inspections have been completed. This was informed by advice provided by the Original Equipment Manufacturer (OEM), GJM.

Until further advised, Ausgrid staff will not be performing any works from EWPs of this make. Alternative arrangements will need to be made where this may present an issue on Connections projects.
