ASP Safety Alert

Alert Number: SA02_17

Subject: Failure to positively identify gas main causing gas main damage

23 March 2017

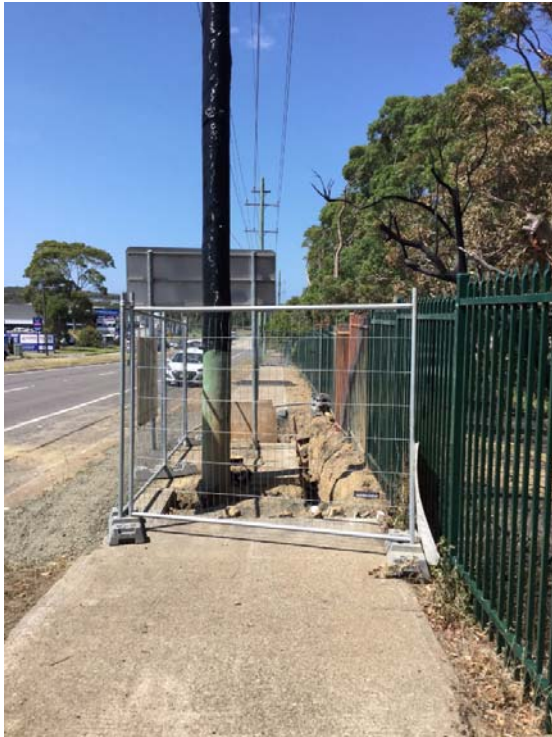
The gas workers also experienced delays in locating the gas main to install the bypass. The weather conditions had changed and light rain created a Coroner effect around the 33KV overhead mains which ignited the escaped gas. This caused a large fire ball and fire in the surrounding area.

The 33KV feeder overhead mains tripped and reclosed immediately. The gas flame continued to burn until the gas workers isolated the mains. There were no injuries, however, there was significant damage to the following:

- an Ausgrid pole, which was subsequently replaced
- ASP1 machinery and power tools
- school fencing
- a traffic sign

Extent of damage

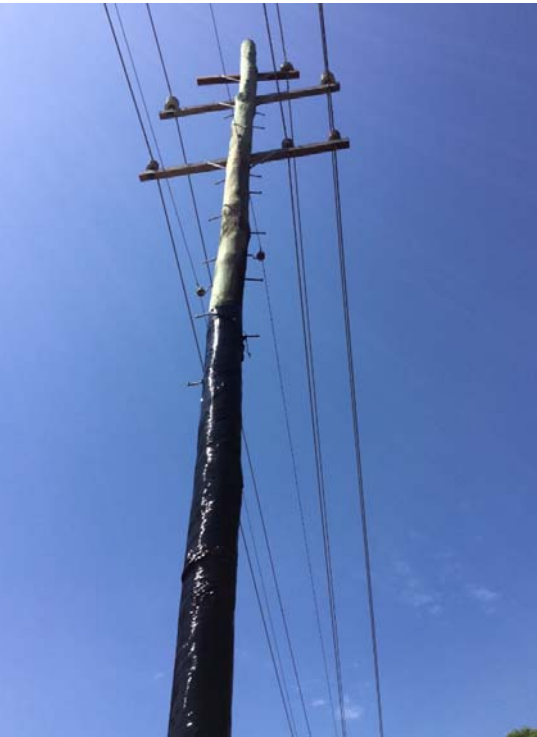
Fire damage and repairs to Ausgrid pole
