ASP Safety Alert

Alert Number: SA08_18

Subject: Security of NS224 Commercial / Industrial Pillars with ABLOY locks

21 June 2018

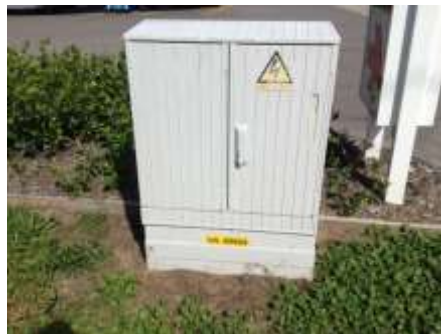
Figure 1. Industrial pillar

Reports of commercial / industrial pillars being found unlocked were reported to Ausgrid from workers in the field. This is potentially a public safety issue. Figure 1 is an example of one of the pillars that utilise the locks that was found unlocked. These pillars have an ABLOY lock installed in the handle with stock code 182232 'Cylinder, Lock, Half European, X27' from the Ausgrid stores system.

- Any worker that identifies a pillar with this issue must report the location and pillar number to Ausgrid Security Operations on 02-9269 2266, the person is requested to remain onsite if possible until assistance arrives to secure the pillar.
- The supplier of the locks has been advised to supply all future locks to Ausgrid with the locking tab set to the fully engaged 90 degree lockable position.
- Ausgrid is implementing a rectification program to inspect all commercial/industrial pillars where Ausgrid has records that these locks were installed and undertake corrective action.

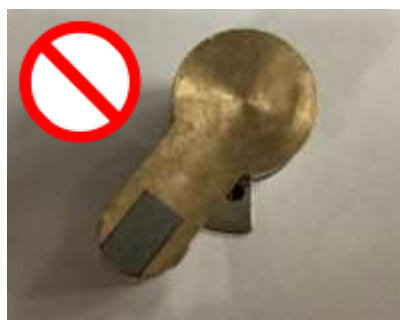
Figure 2. Tab in the 30 degree position

Initial investigations lead Ausgrid to believe that the Abloy locks which are located in the handle of the pillar have for some time been supplied with the locking tab set in the 30 degree position, shown in Figure 2. This has led to the handle not latching sufficiently within the door frame when locked. Locks in this configuration have been supplied to the Ausgrid stores. Enquiries into the supply of the locks has identified that locks have been supplied to Ausgrid since 2011 with uncertainty around the position of the locking tab.

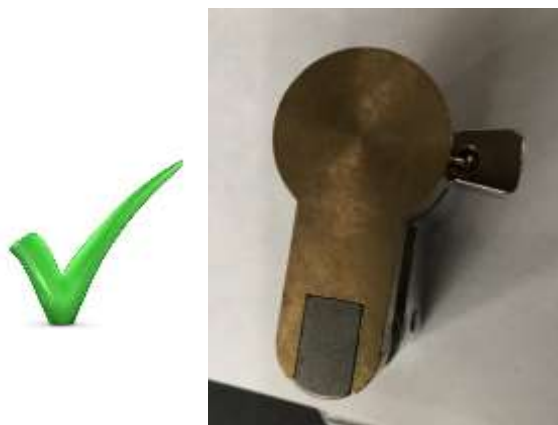
Figure 3. Adjusted lock with tab at 90 degrees

Figure 3 shows an ABLOY lock with the tab in the required position for installation and the position that all future locks will be supplied.

Note: Prior to commissioning the pillar, it must be confirmed by the ASP installing the pillar that each lock is correctly installed and fully engaged i.e. locking tab at 90 degrees to the lock barrel, when the lock is in the locked position.
