ASP General Information Service & Installation Compliance

Alert Number: GI10_23

Subject: Live fixing bolts of SPD/MPD fuse holder bases

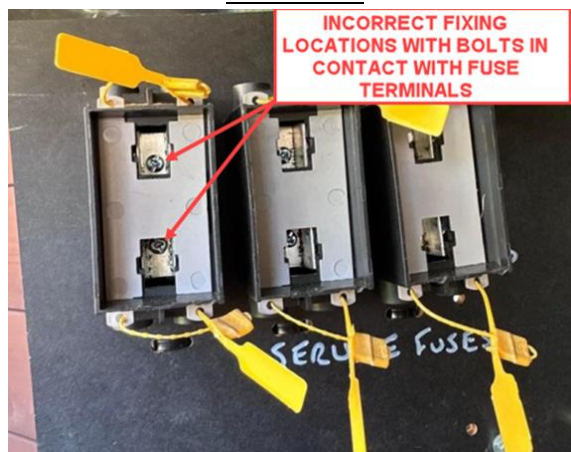
Panel Front

Ausgrid has been notified of an electric shock received by an electrical contractor when coming into contact with the conductive bolts used to secure the service fuses to switchboard panel. The service fuses had been drilled and fastened with the conductive bolts touching the terminals on both line and load side of the fuse bases. With the fuses removed, the line side terminals of the fuse holder bases and respective mounting bolts/nuts remained energised.

Further investigation identified the associated service work was notified to Ausgrid in 2015. The below photos show the exposed conductive bolts affixed through the terminals of the fuse holder base.

ASPs are reminded to not work live on customer's installations, test to ensure exposed parts are not live ("assume energised until proven (tested) de-energised") and to follow manufacturer's instructions when installing equipment.

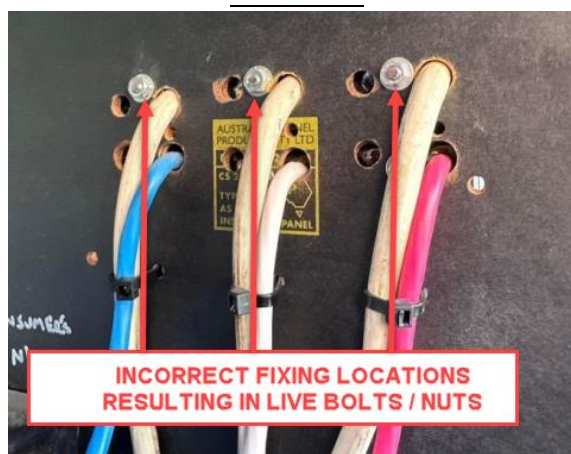
Panel Rear

While there is no specific test required by AS3000 or NS282 which would identify this hazard, one likely indicator would be the use of two fixing nuts at the rear of the hinged switchboard panel, behind each service fuse. When installed in accordance with the manufacturer's instructions, only one fixing nut should be present between the incoming and outgoing conductors terminated at the line/load terminals of each fuse holder base.

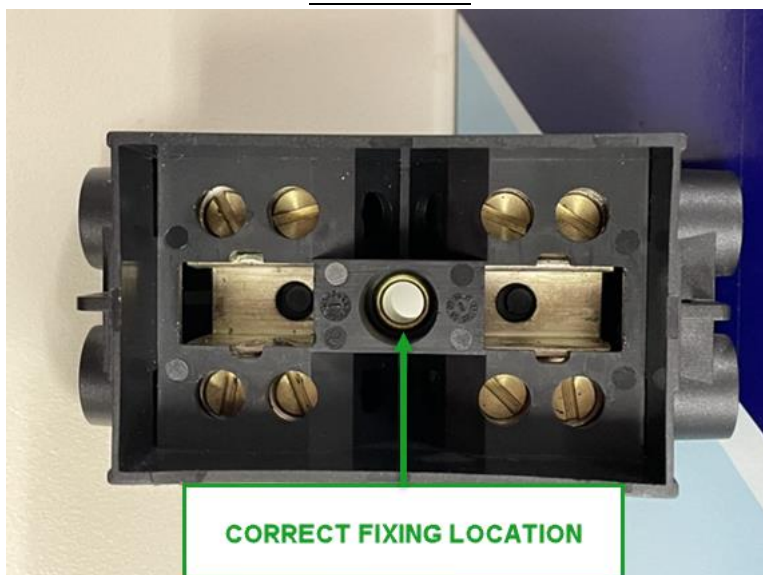
The correct fixing method using the mounting hole (located in the centre) provided by the manufacturer is shown below.
