# ASP Safety Alert

**Alert Number: SA05\_17**

**Subject: Pole failure after removal of overhead mains**

5 July 2017

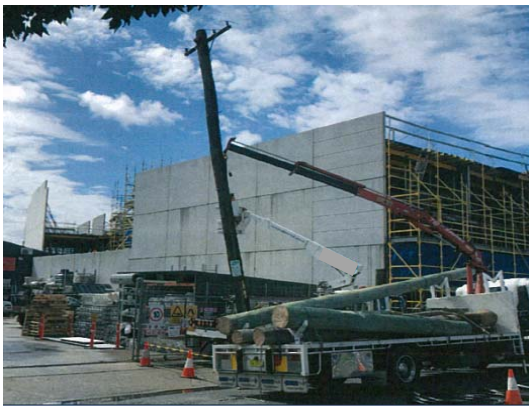
Picture 1 showing pole had failed and was held

ASP1 work crews were replacing existing bare LV mains with twin 4 x 95 ABC to maintain safety distances to a new building under construction. The pole was an inline supporting pole with a pin construction. Once the bare mains had been removed, the workers heard a cracking noise and witnessed the pole head move. They immediately stopped work and positioned a Hiab crane to hold the pole and make the site safe.

The pole was found to be rotted below ground level, the fracture point was measured at 700mm below ground level. The pole was replaced that afternoon.

**Prior to completing work on poles ensure the pole is inspected and tested as per Ausgrid's procedure outlined in NS146**

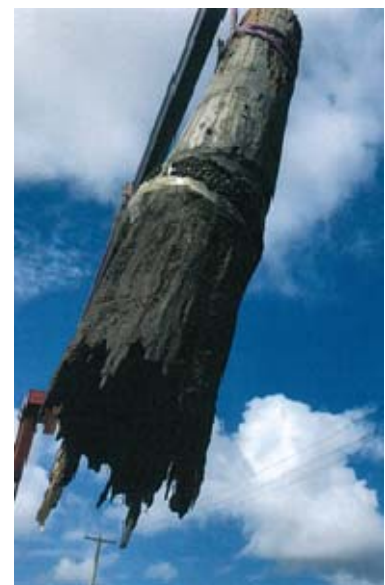
The investigation found the workers **had not completed the necessary pole inspections and testing**, which included below ground level assessment, to ascertain the condition of the poles being worked on that day. Ausgrid's network standard NS146 *Inspection procedure for working on poles* outlines the following:

Picture 2 showing pole deteriorated condition

- > **'progressively excavate, inspect, and sound with bar... to a depth of 350mm'**
