Safety Alert

Alert Number: SA04_17
Subject: Cable Strike Incident

Date: 19 April 2017

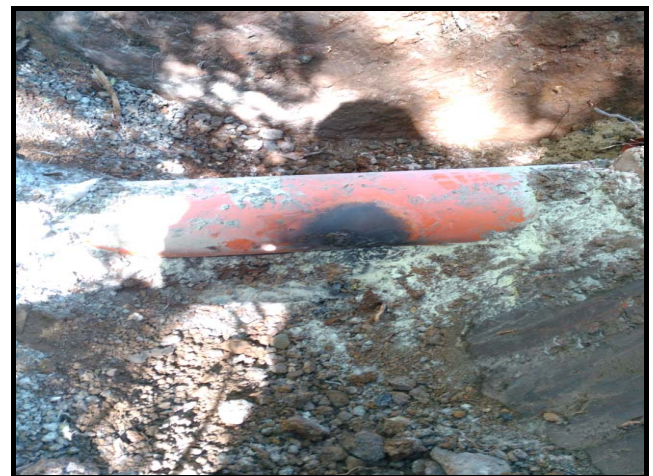
An ASP1 contestable works assistant (CWA) hit and damaged an in-service 11kV feeder cable at Wahroonga with the jack hammer. The feeder cable was located approximately 800mm from the property boundary and buried at 500mm to 600mm deep. The cable was situated with Ausgrid's standard allocation and was indicated on the DBYD plans and the Ausgrid certified design.

A cable scan of existing assets was conducted prior to work commencing but failed to identify all known cables that were indicated on the certified design and dial before you dig plans.

- Not positively identifying all cables prior to starting mechanical excavation works near the network.
- Using a jack hammer within minimum clearances of existing live UG cables

Re-affirm the importance of always following the requirements of the ESR, NS156 and NS165.

- **Consideration of the requirement for an access permit when digging near cables;**
- **Having up to date and legible DBYD, and where required Network or Service Location Diagrams;**
- **Use of potholing or vacuum excavation methods to positively identify all UG assets prior to commencing mechanical excavation activities; and**
- **The importance of maintaining communication with equipment operators and observers when excavation works near known network cables.**
