# ASP Safety Alert Electrical Safety & Authorisations

Alert Number: SA13\_19

## Subject: Ausgrid worker applied low voltage shorts to live distributor

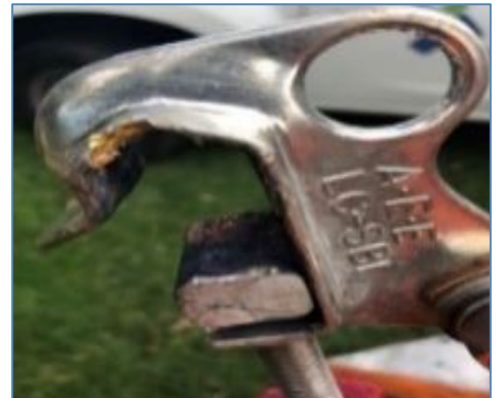
The Line Worker performed the full lamp test to confirm the low voltage conductors were de-energised and then confirmed this no-glow result by testing the lamps with the test lamp tester.

The low voltage shorts were then applied connecting neutral first, followed by C phase then B phase. A flash occurred when the Line Worker was attempting to apply the last short to A phase.

- **Make workers aware of the difficulties of observing a clear lamp test result in bright conditions through the non-transparent plastic of the test lamps**
- **When lamping, ensure that you visually see the test lamp globes**

Immediately following the incident, the job was paused, and refresher training was arranged for Low Voltage Lamping and RF11 training.
