ASP Safety Alert Network Compliance & Authorisations

Alert Number: SA08_22

Subject: MEWP Fatality Mareeba

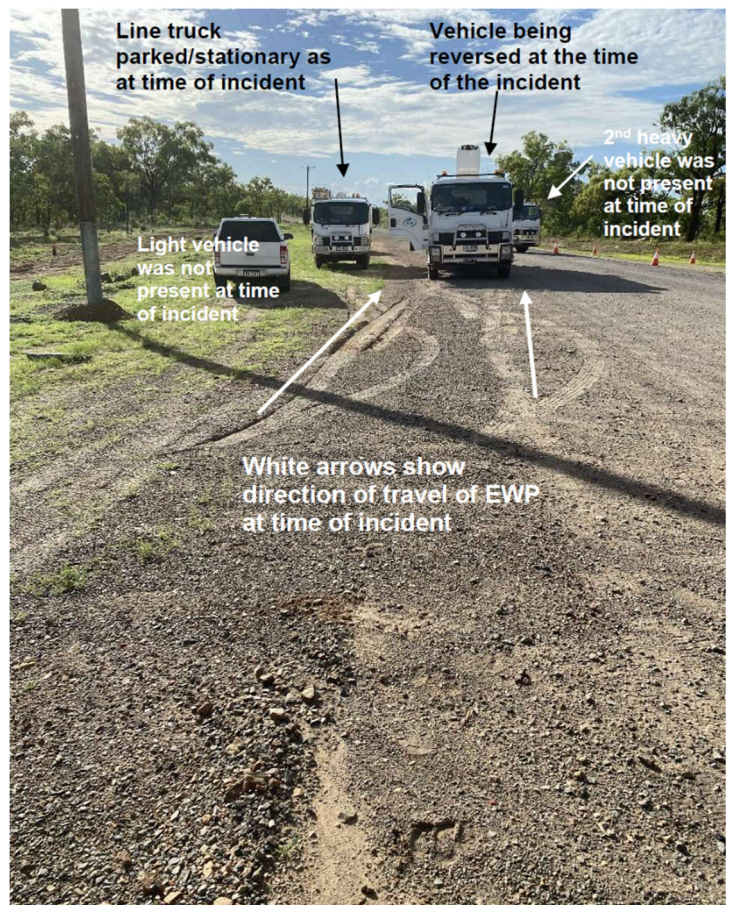
Evidence indicates the contact occurred at the rear passenger side of the MEWP, resulting in fatal injuries.

An inspection of the vehicle confirmed the reversing camera, mirrors and reversing beeper were operational at the time of the incident. General visibility and weather conditions at the time were both clear.

Many distractions can arise onsite, such as using a mobile device, so it is imperative that workers remain aware of their surroundings when working in close proximity to heavy vehicles and roads.
Workers should ensure they are visible to the operator of vehicle when they are moving.
Vehicle operators should use a spotter and not rely solely on reversing sensors and cameras.
