# Network Standard

**NS262**

**Private mains bush fire risk audit**

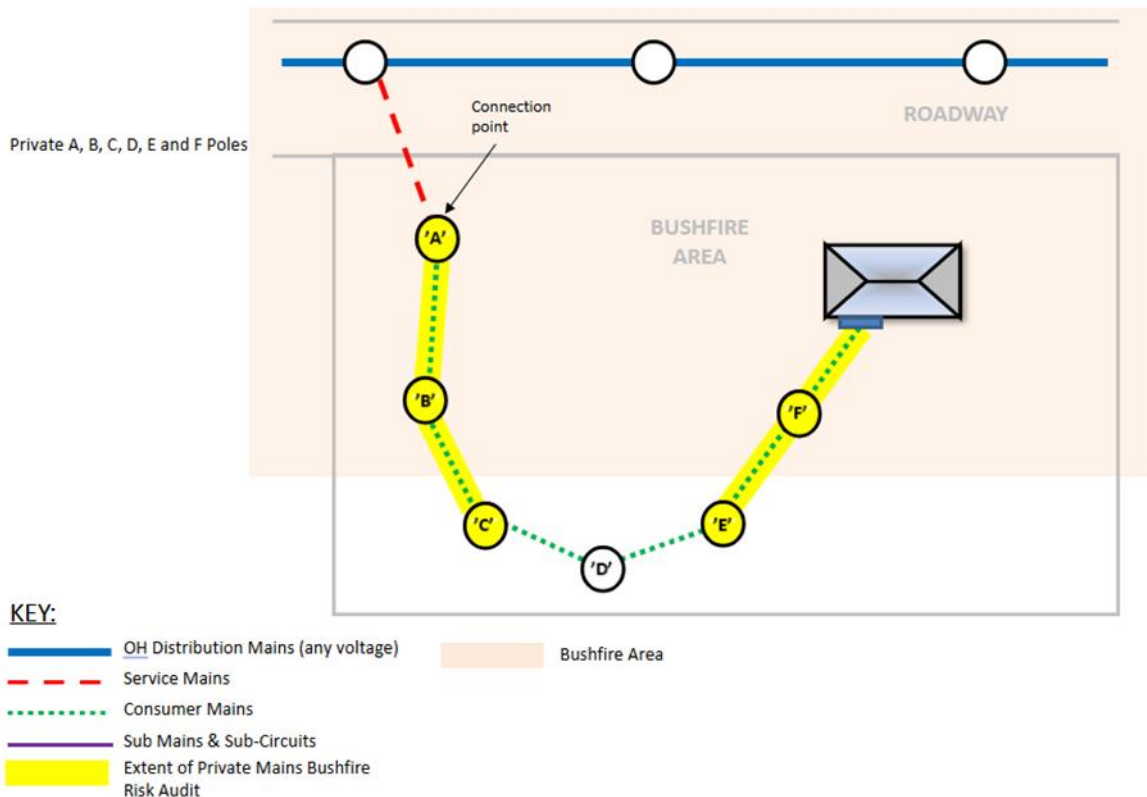
**B1 SCENARIO INVOLVING SERVICE MAINS AND CONSUMERS' MAINS**  
**Consumers Mains Inside and Outside of Bushfire Areas**

All aerial consumers mains located in bushfire prone areas (including any portion of a span and supporting structures for those spans) shall be audited.

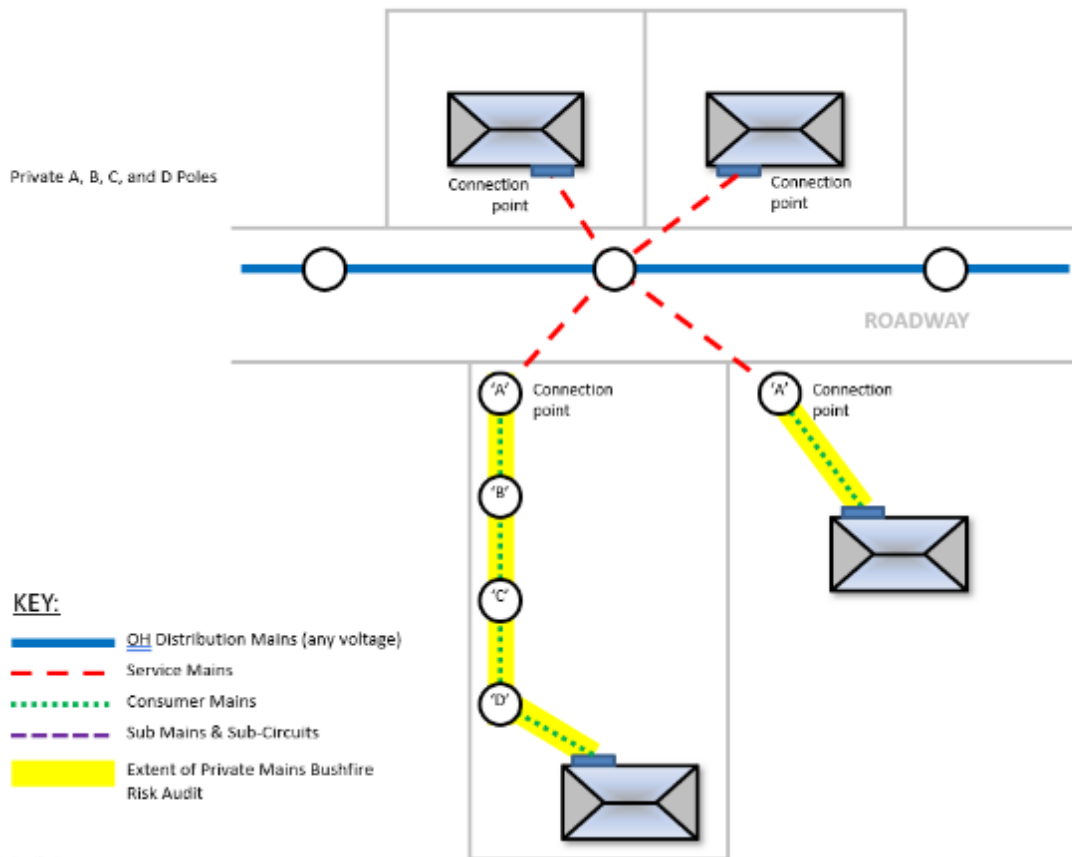
**Single Customers Supplied via Service Mains or both Service & Consumers Mains**

All aerial consumers mains (including supporting structures) shall be audited. The consumers mains in the scenario above are the conductors between the Connection Points (i.e. 'A' Pole) and the various customer main switchboards.

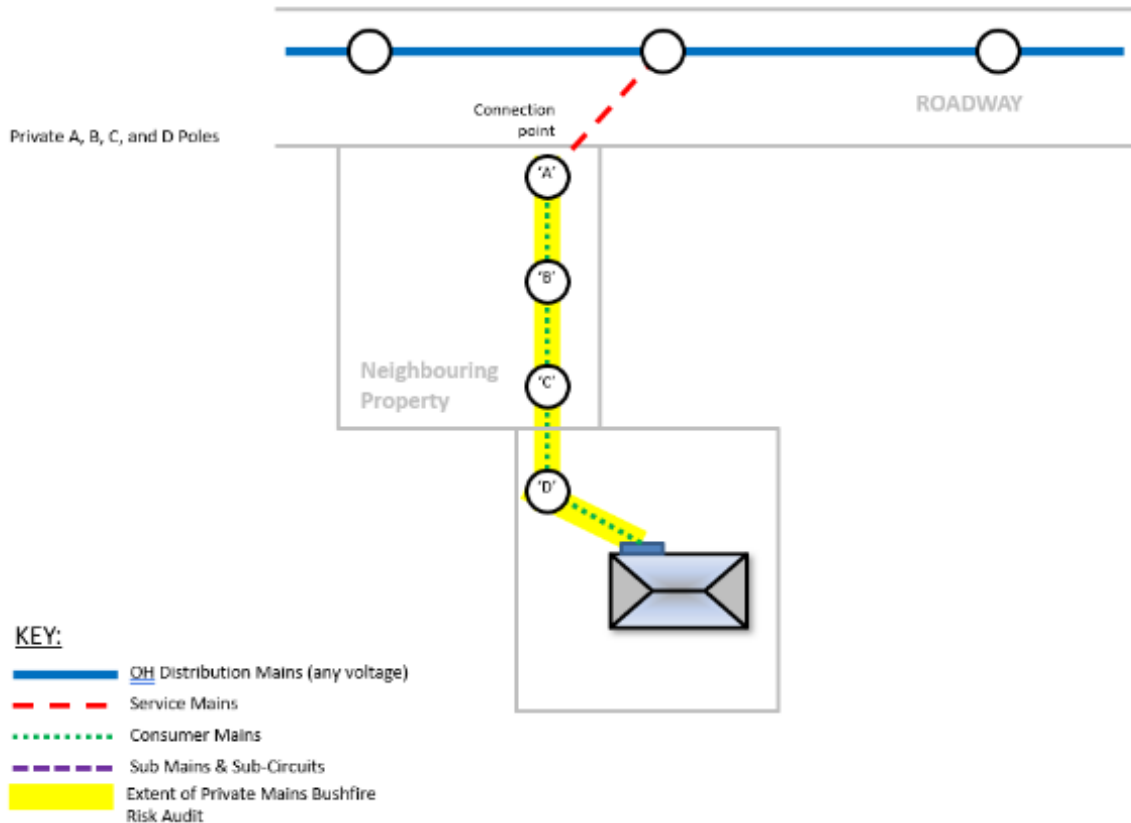
## Single Customer Supplied via Neighbouring Property

All aerial consumers mains (including supporting structures) shall be audited. The consumers mains in the scenario above are the conductors between the Connection Point (i.e. 'A' Pole) and the customer main switchboard.

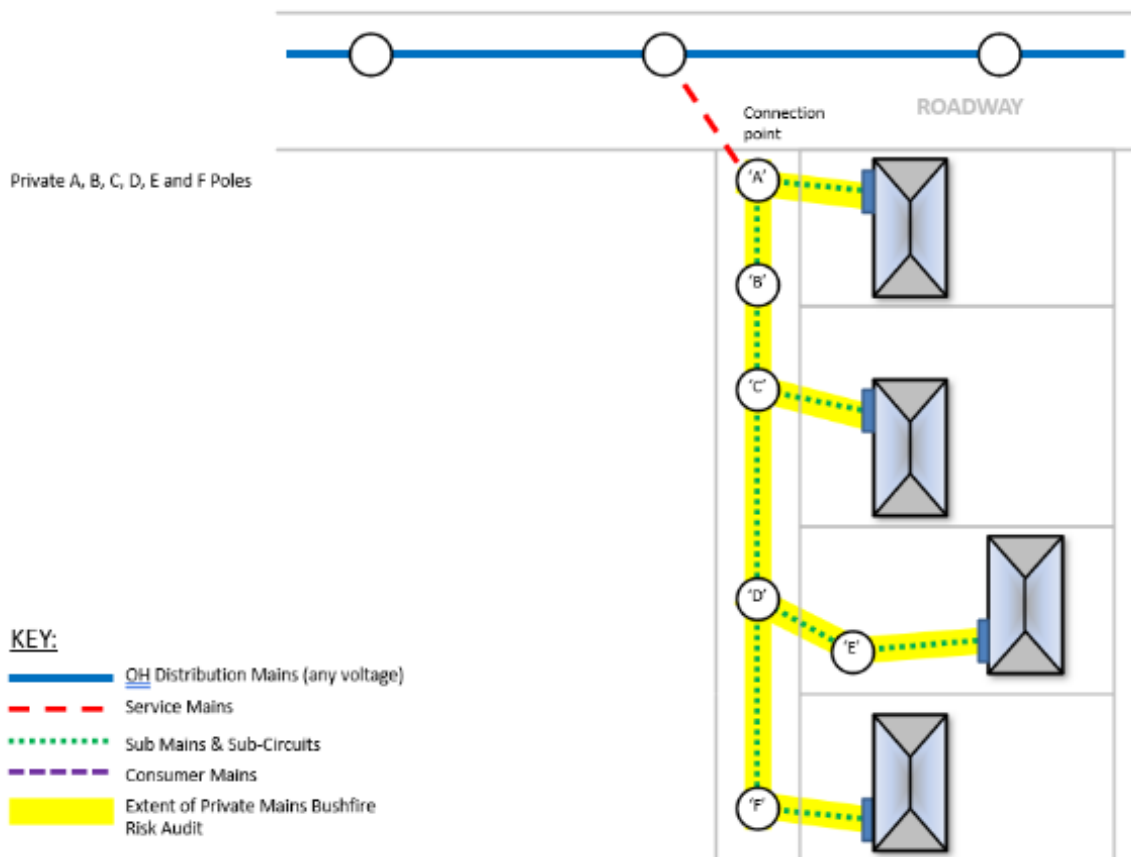
### Multiple Customers Supplied via Private Poles along a Shared Driveway

Only aerial consumers mains (including supporting structures) shall be audited. The consumers mains in the scenario above are the conductors between the Connection Point (i.e. 'A' Pole) and each of the customer main switchboards.

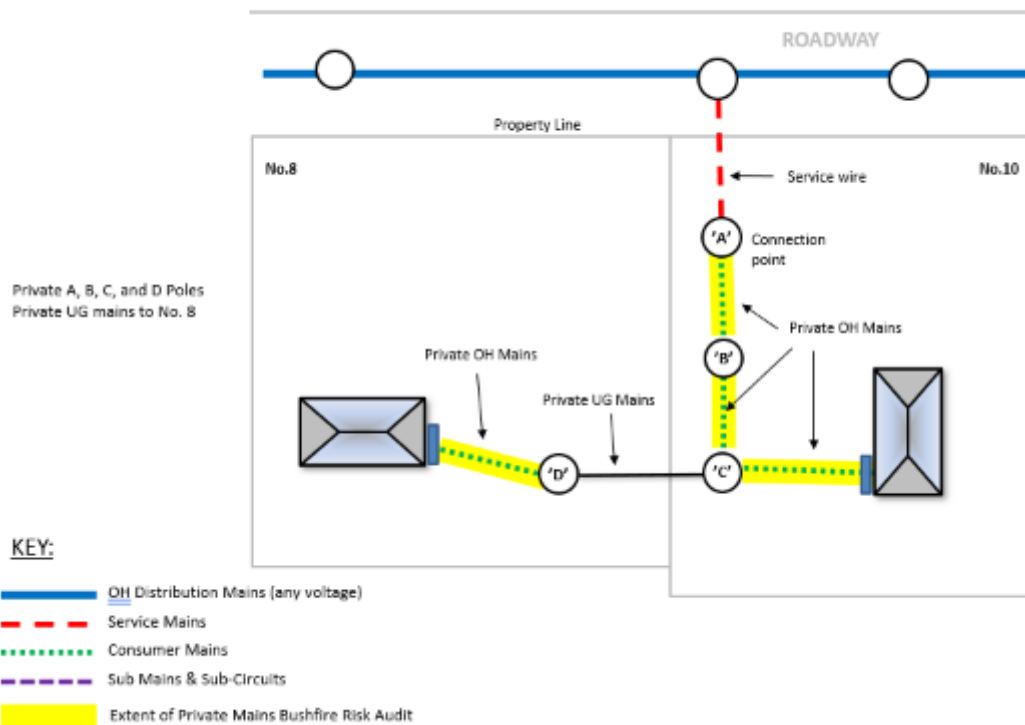
### Multiple Customers Supplied via Private Poles and Underground Private Mains

Only aerial consumers mains (including supporting structures) shall be audited, including the above ground portions of the private underground mains. The consumers mains in the scenario above are the conductors between the Connection Point (i.e. 'A' Pole) and each of the customer main switchboards.

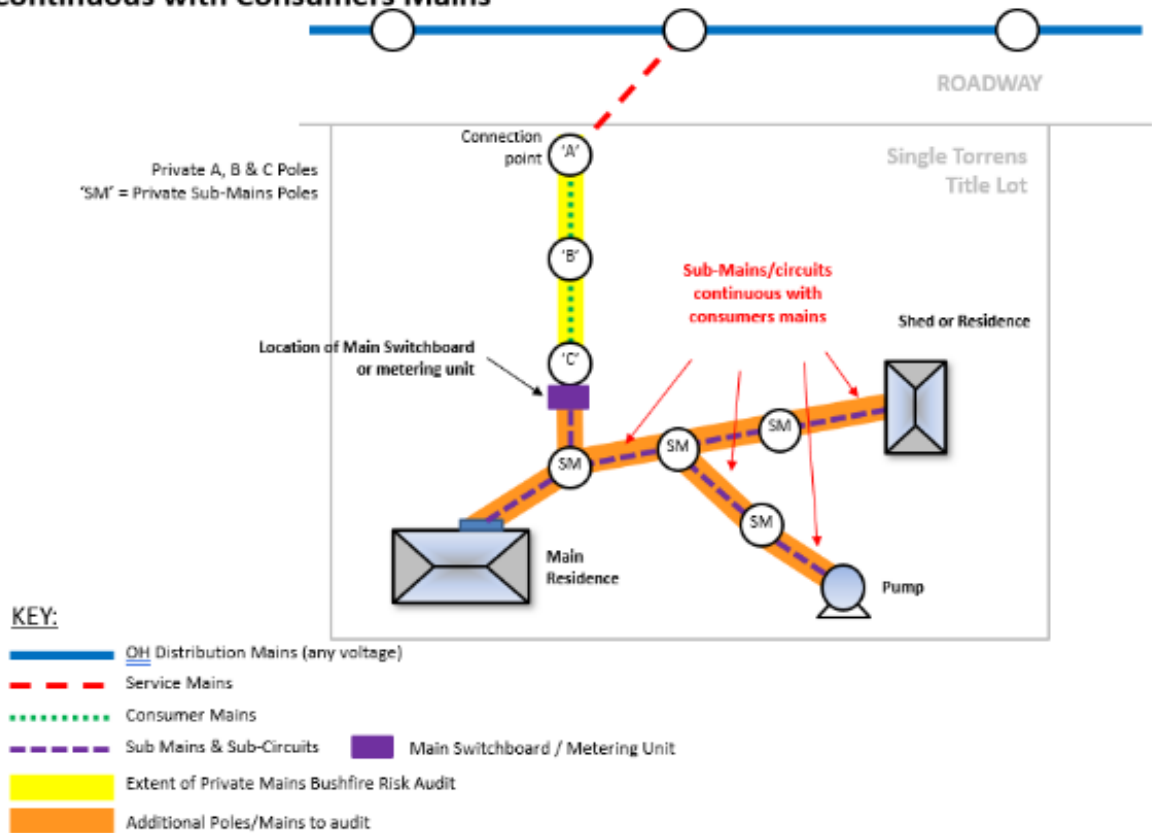
### Multiple Residence on a Single Torrens Title Lot – with Sub-Mains/Circuits Continuous with Consumers Mains

Aerial consumers mains (including supporting structures) shall be audited. The consumers mains in the scenario above are the conductors between the Connection Point (i.e. 'A' Pole) and the first customer main switchboard or metering unit.

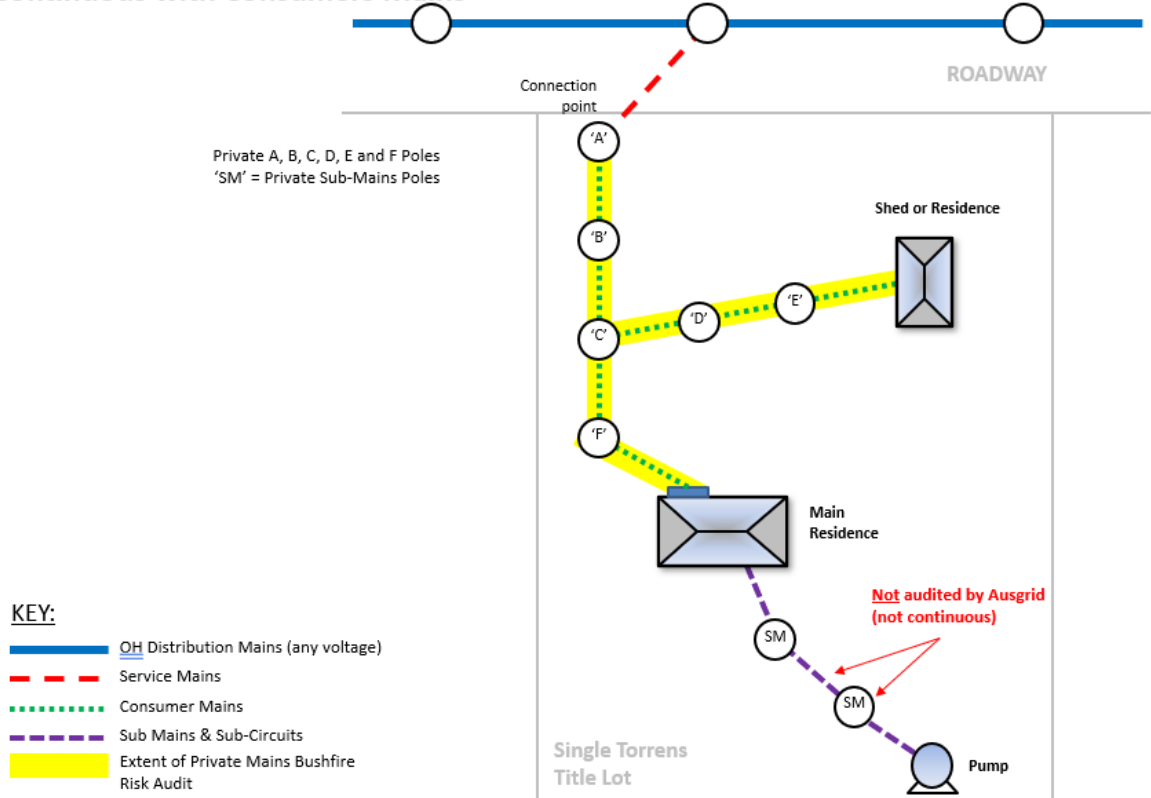
**Multiple Residence on a Single Torrens Title Lot – with Sub-Mains/Circuits not Continuous with Consumers Mains**

Aerial consumers mains (including supporting structures) shall be audited. The consumers mains in the scenario above are the conductors between the Connection Point (i.e. 'A' Pole) and the first customer main switchboard or metering unit.

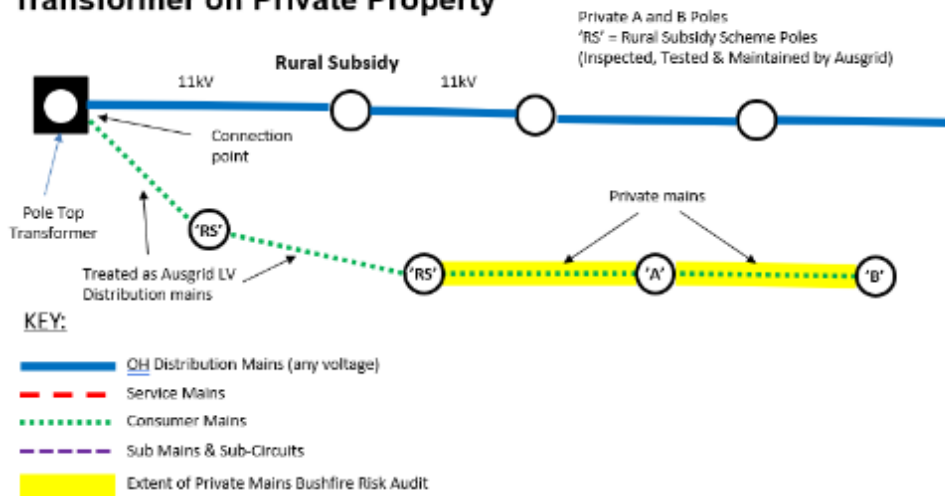
### Rural Subsidy Scheme Scenario – Supply from Pole Top Transformer on Private Property

Aerial consumers mains (including supporting structures) shall be audited. The consumers mains in the scenario above are the conductors between the last rural subsidy scheme pole and the first customer main switchboard or metering unit.

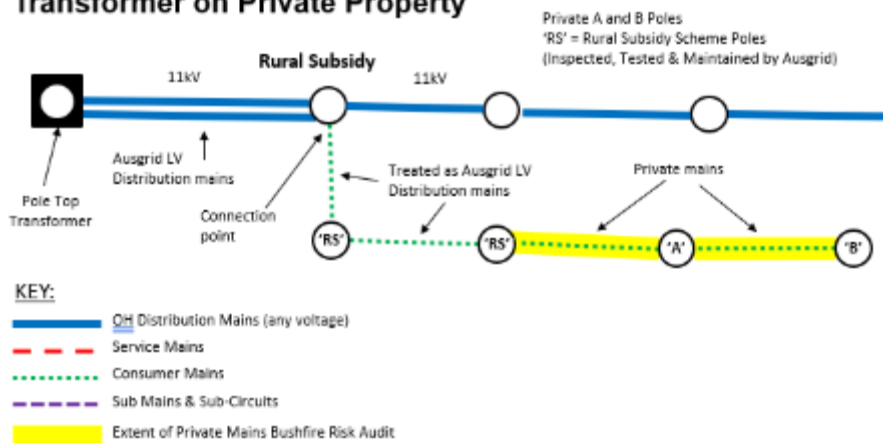
### Rural Subsidy Scheme Scenario – Supply from Pole Top Transformer on Private Property

In this scenario, the LV mains between the two Ausgrid poles and to the last RS pole are treated as Ausgrid distribution mains. Aerial consumers mains (including supporting structures) shall be audited. The consumers mains in the scenario above are the conductors between the last rural subsidy scheme pole and the first customer main switchboard or metering unit.

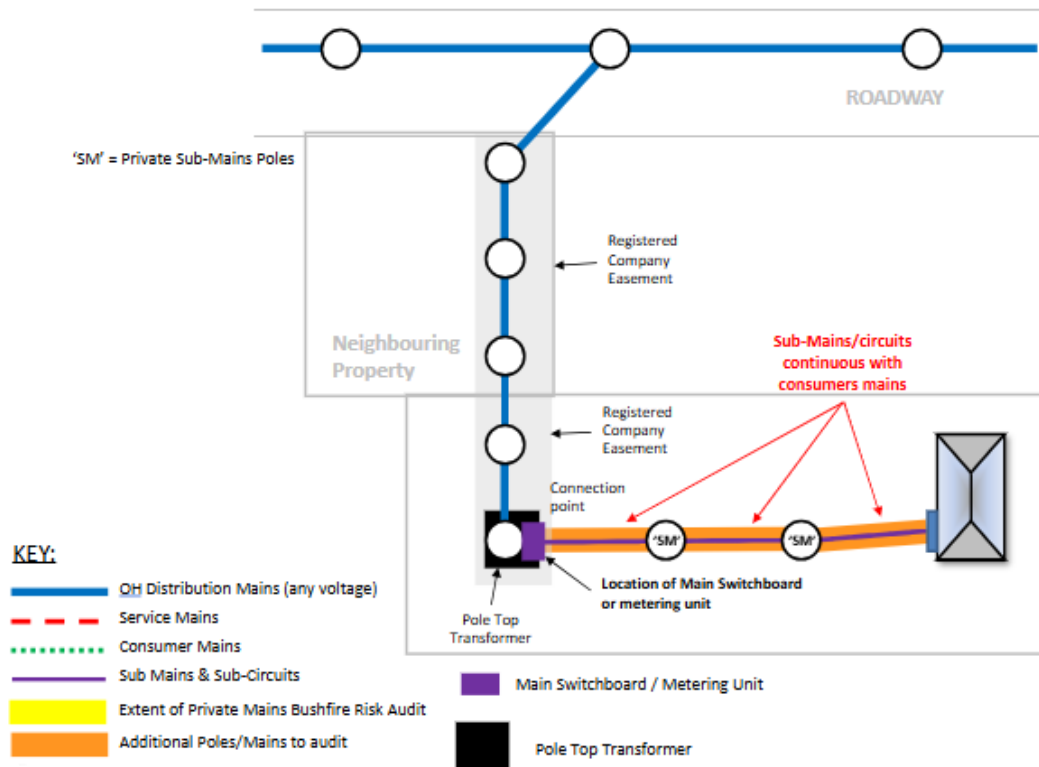
### Residence with a Pole Top Transformer – with Sub-Mains/Circuits Continuous with Distribution Mains

In this scenario the Connection Point and the first main switchboard or metering unit are located at the same place (i.e. the first main switchboard or metering is mounted on a pole). In this case the extent of auditing shall be extended to include the sub-mains between the Connection Point and the customer main switchboard located at the main residence.

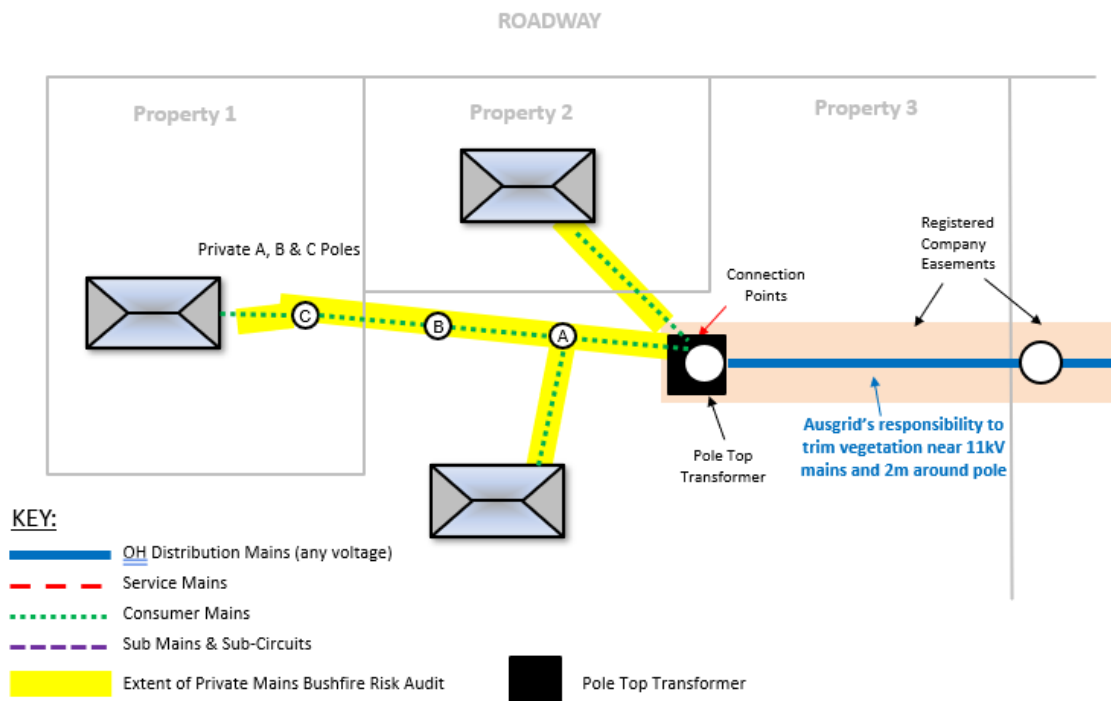
## Residence with a Pole Top Transformer in Bushfire Prone Land – with Consumers Mains To Adjacent Residences (not Rural Subsidy Scheme)

In this scenario the Connection Points for two residences are located at the pole transformer and a further Connection Point (to Property 3) is at pole 'A'. In this case the extent of auditing shall be between the Connection Points and the customer main switchboard located at each residence.

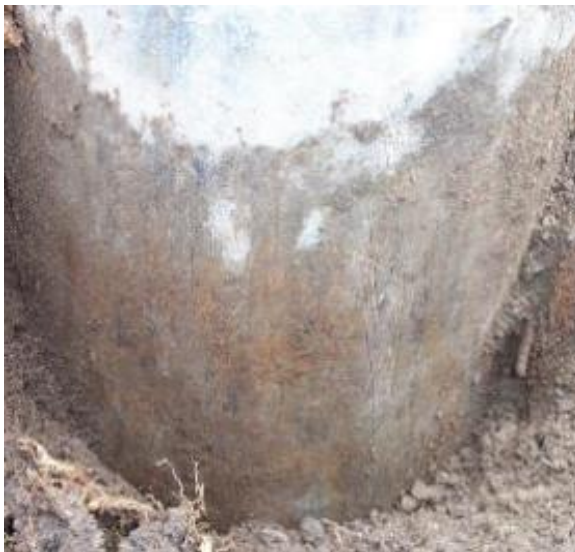
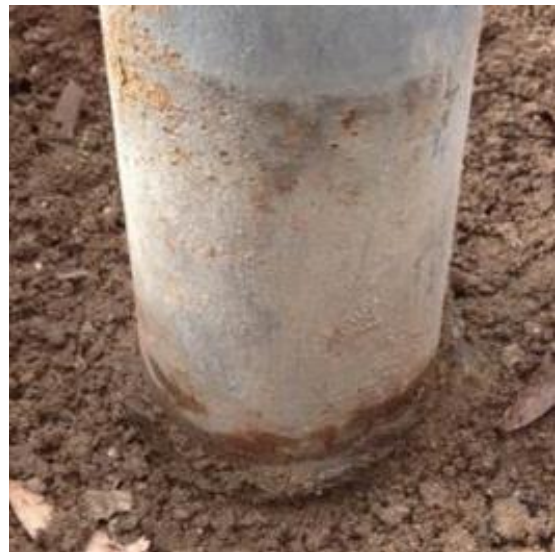
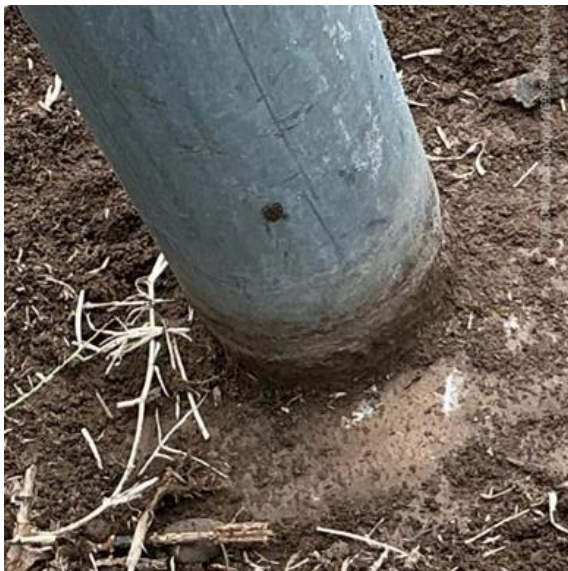
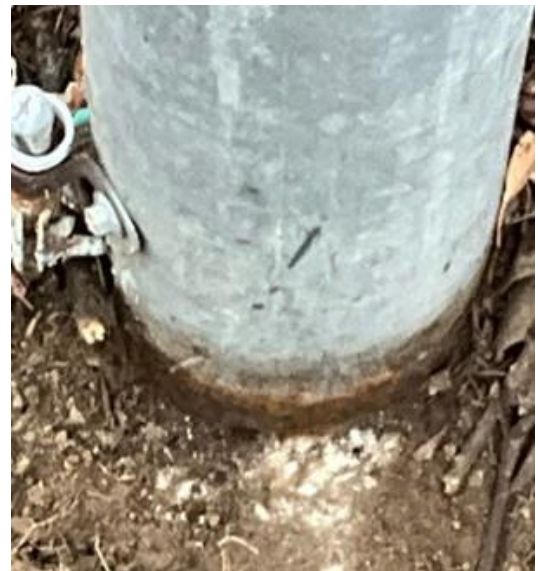
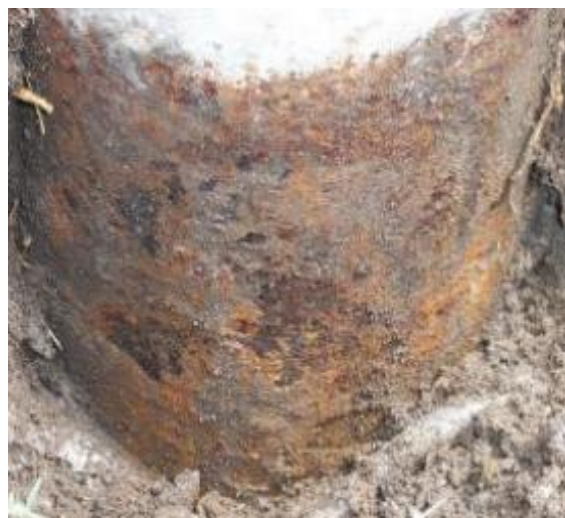
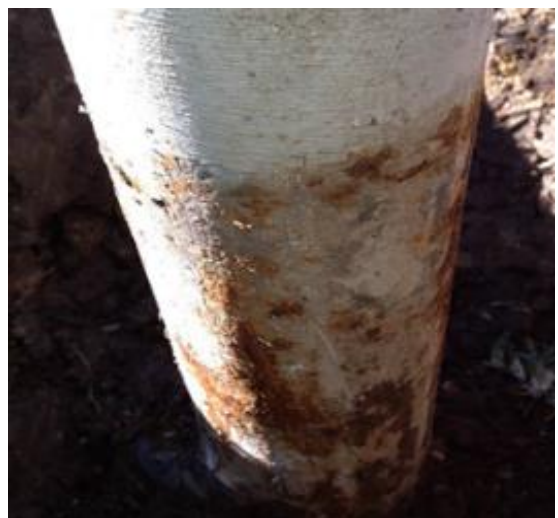
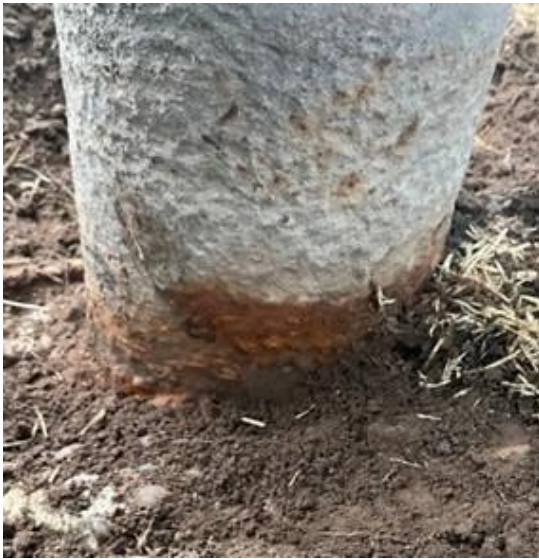
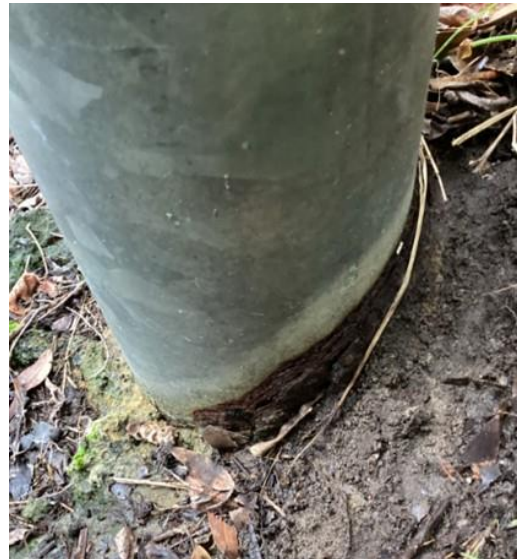
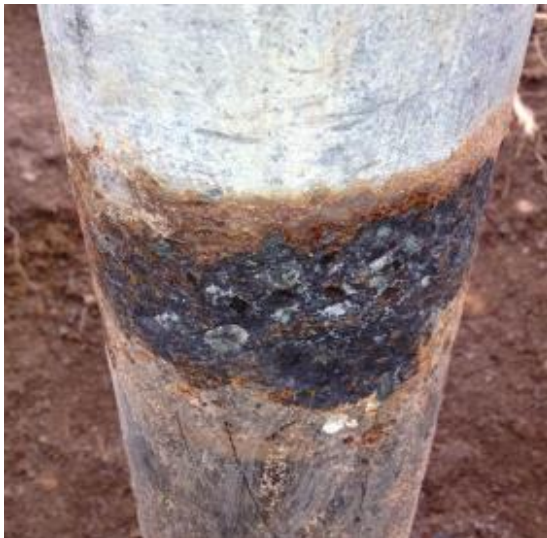
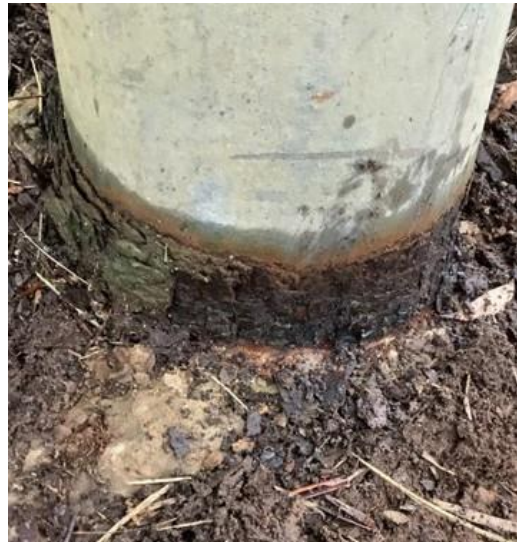
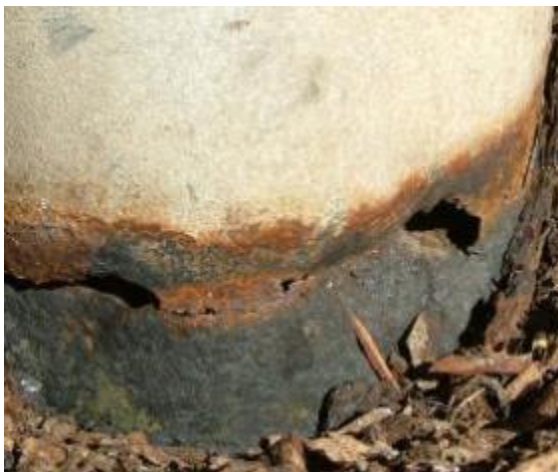
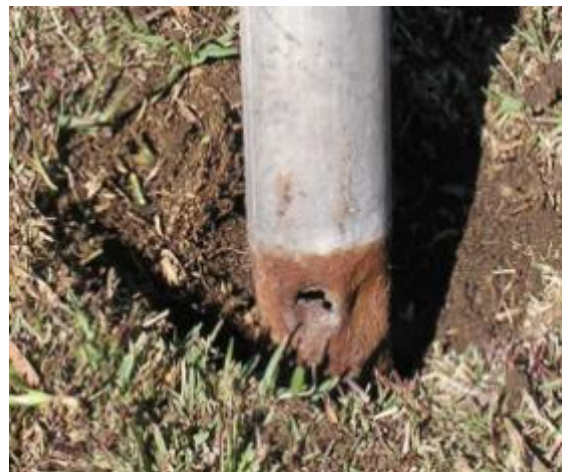
**Figure 8 – Common steel pole defects**

**(a) Pole is serviceable**

**(b) Pole is serviceable**

**(c) Pole is serviceable**

**(d) Maintenance letter**

**(e) Maintenance letter**

**(f) Maintenance letter**

(g) Maintenance letter

(h) Defect notice

(i) Defect Notice

(j) Defect notice

(k) Emergency Line and Defect notice

(l) Emergency Line and Defect notice

Figure 8 (l) shows a perforation and denting, both of which significantly reduce the strength of the pole. These defects shall be immediately reported to the Ausgrid Emergency Line and reported to the customer by issuing a Defect notice.

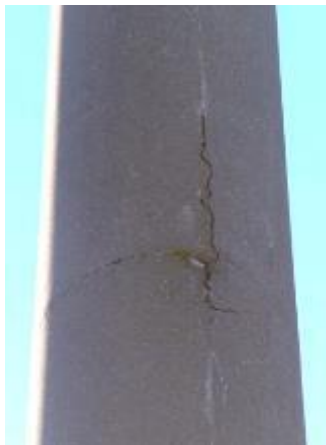
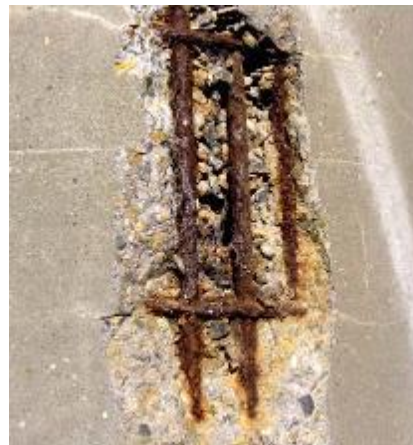
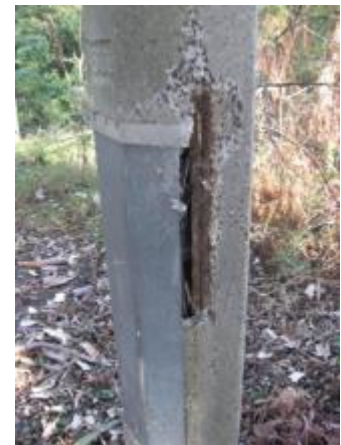
**Figure 9 – Common Concrete Private Pole Defects**

(a) Maintenance letter

(b) Defect notice

(c) Defect notice

Figure 9 (c) shows spalling which has progressed to the point where spalling has penetrated the full depth or cross-section of the concrete pole, and the reinforcing bars are fully exposed. These defects shall be reported to the customer by issuing a Defect notice.

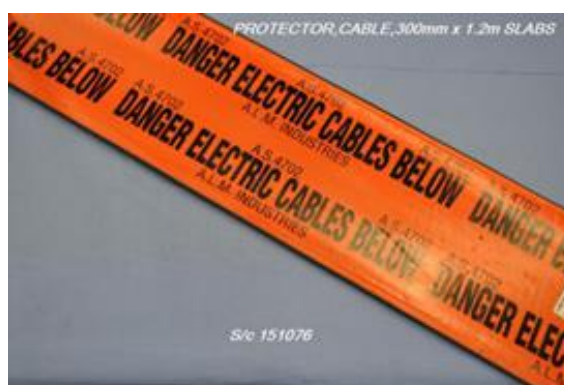
Figure 11 – Cable Protection Covers

Electrical assets installed underground may be covered with a cable protection cover. Private Mains Auditors shall not remove cable protection covers found in the excavation area surrounding a pole to enable the pole to be fully exposed for assessment.

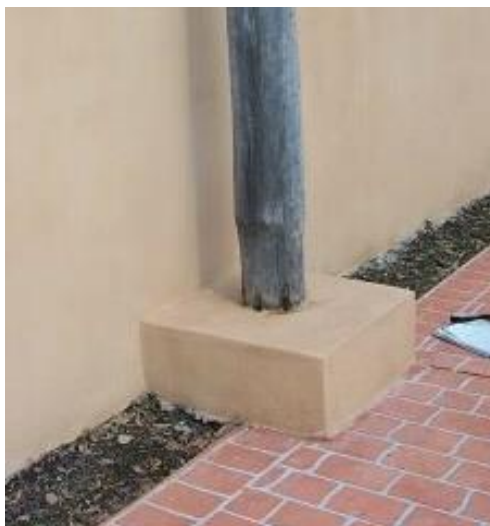
**Figure 12 – Inaccessible Pole**

Direct buried timber and steel private poles shall be accessible for below ground assessment. Where they are found in locations where they cannot be correctly assessed (an example is shown in Figure 12), the situation shall be reported to the customer (where reasonably contactable) and the customer notified with an 'Unable to inspect' letter (excluding steel poles originally installed according to AS/NZS 3000:2018).
