# **Review of Environmental Factors**

## **Hunter-Central Coast REZ Network Infrastructure**

**Appendix F – Contamination Reports**

Report on  
Preliminary Site Investigation (Contamination)

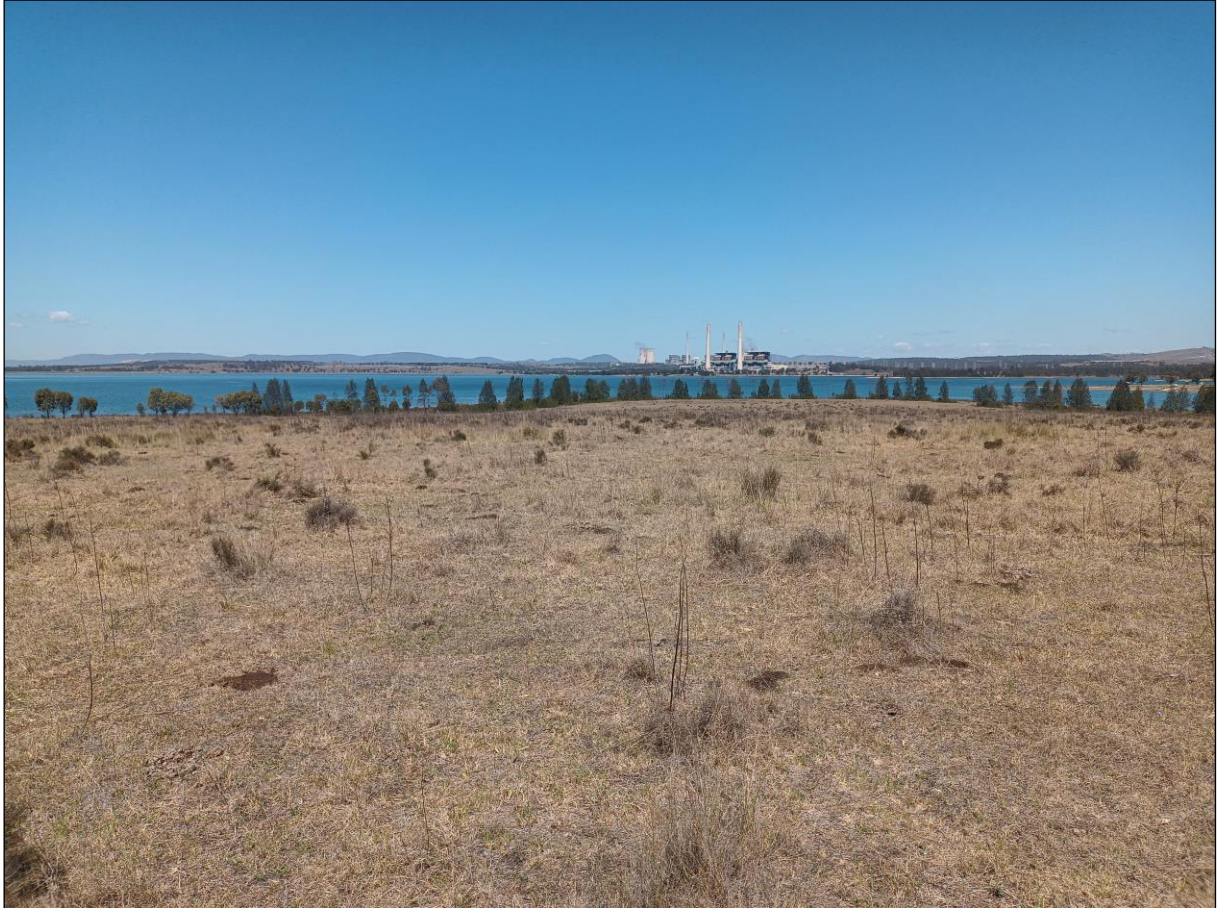
**Photograph E1: Looking south-west from the central portion of the site**

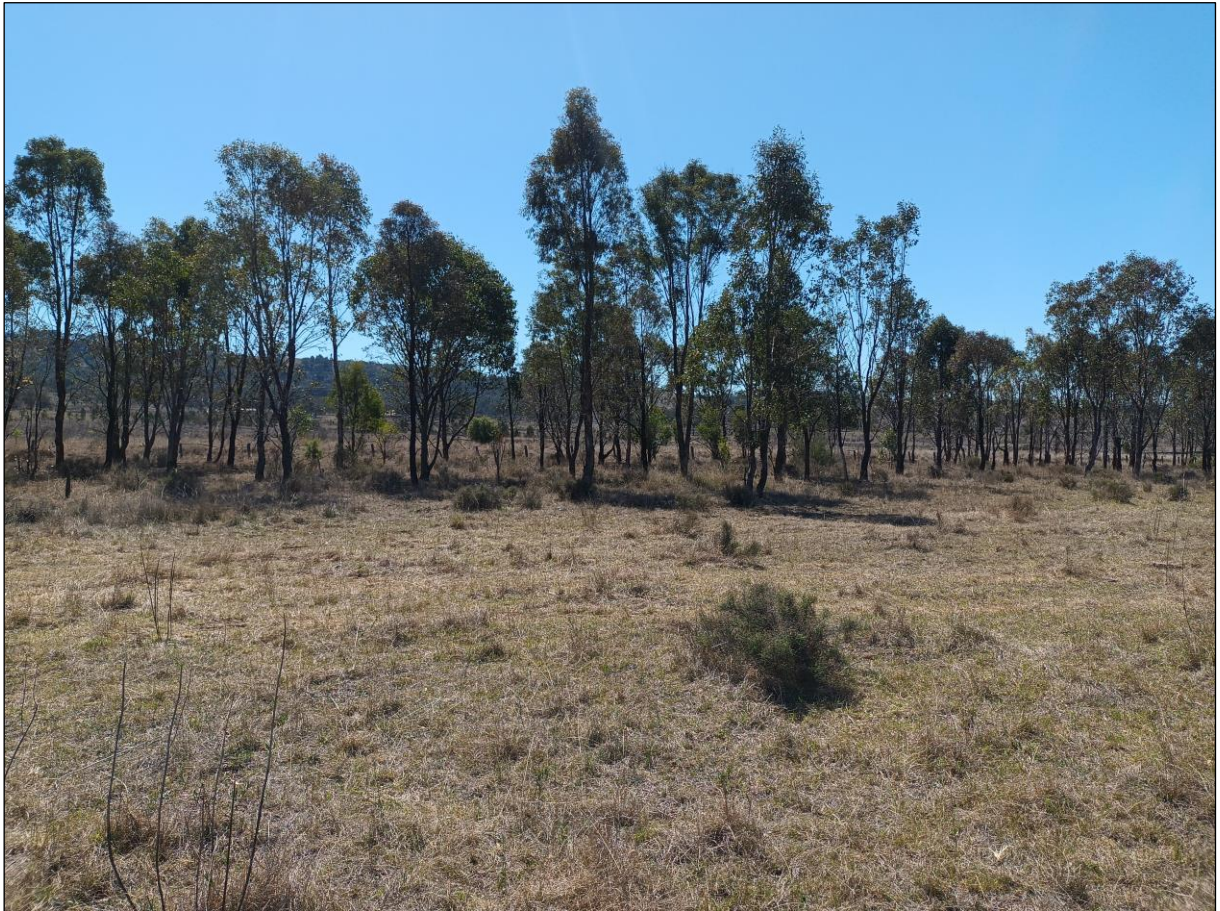
Mature trees were observed in the north-western portion of the site (Photograph E2). Hebden Road was located immediately north of the northern site boundary (Photograph E3)

**Photograph E3: Northern boundary and Hebden Road (behind trees) in the northern portion of the site**

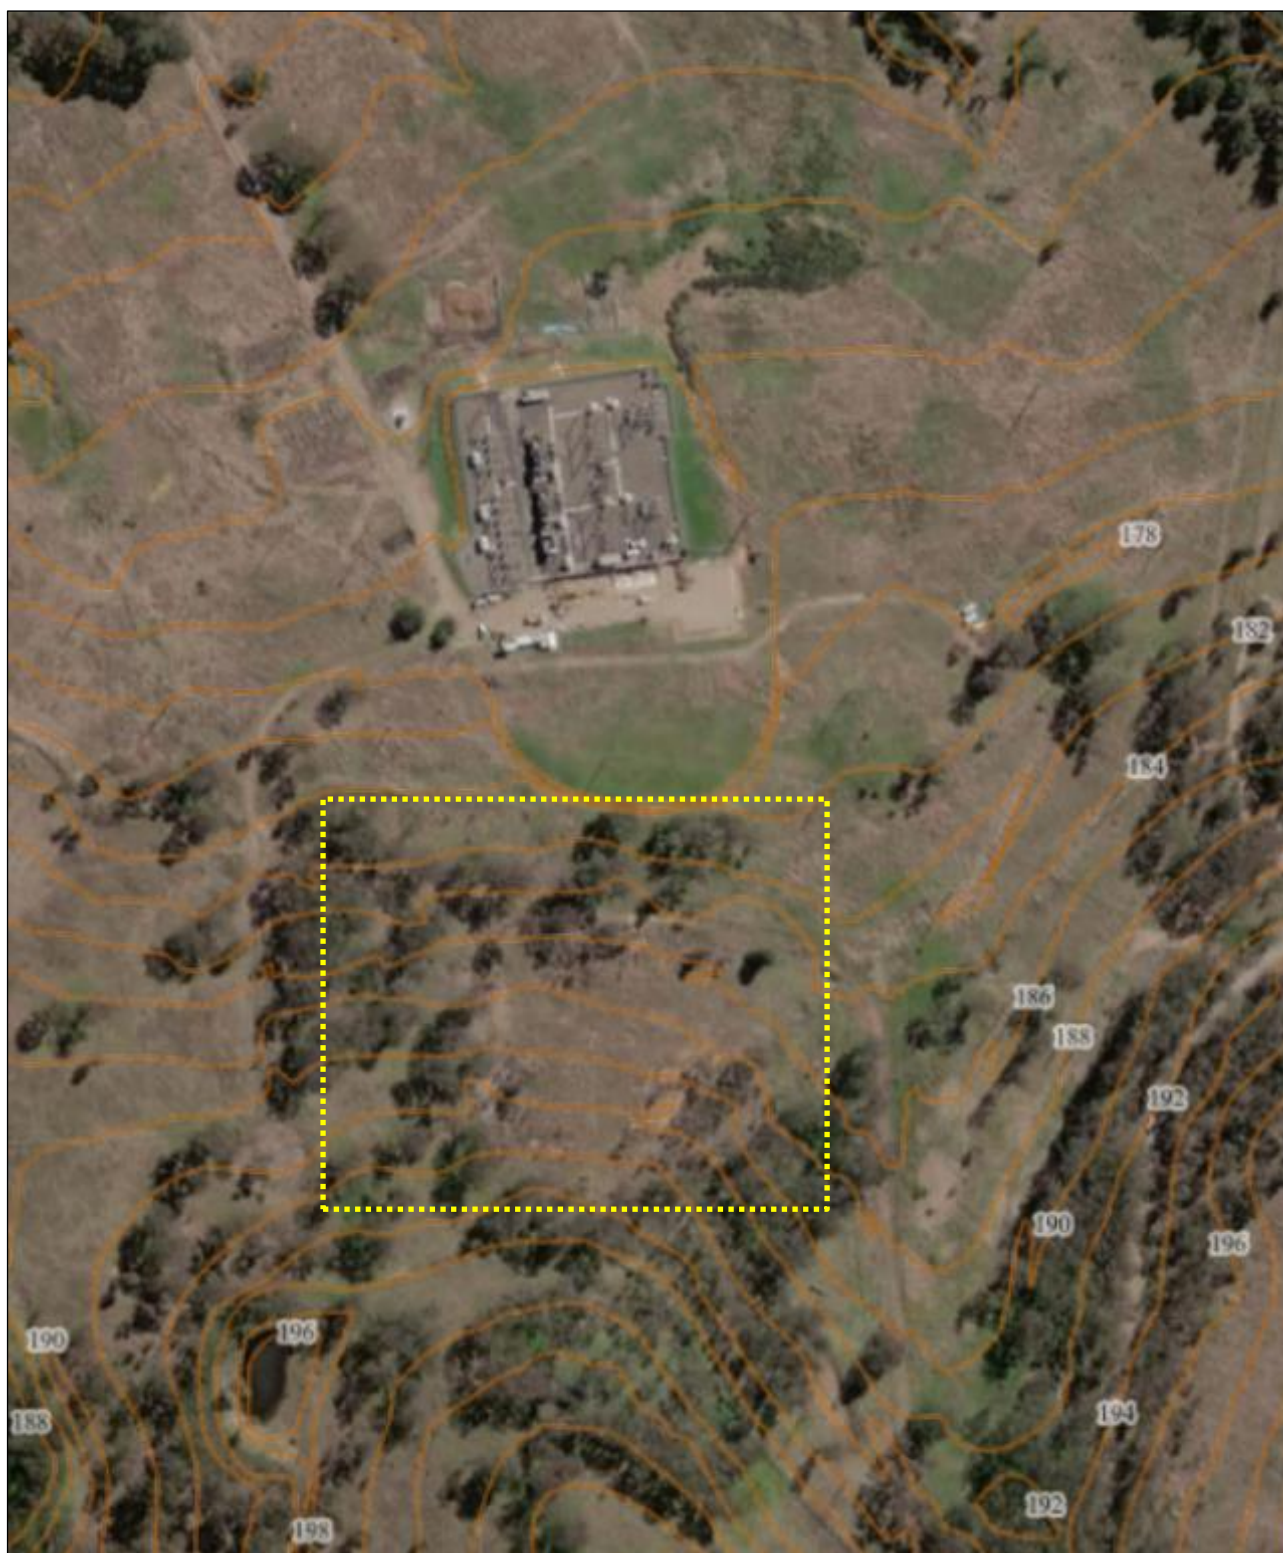
**Figure 2: Site topography (approximate extent of site in yellow)**

Based on the regional topography and the inferred flow direction of nearby water courses, the anticipated flow direction of groundwater beneath the site is to the west, towards Sandy Creek, the likely receiving surface water body for the groundwater flow path.

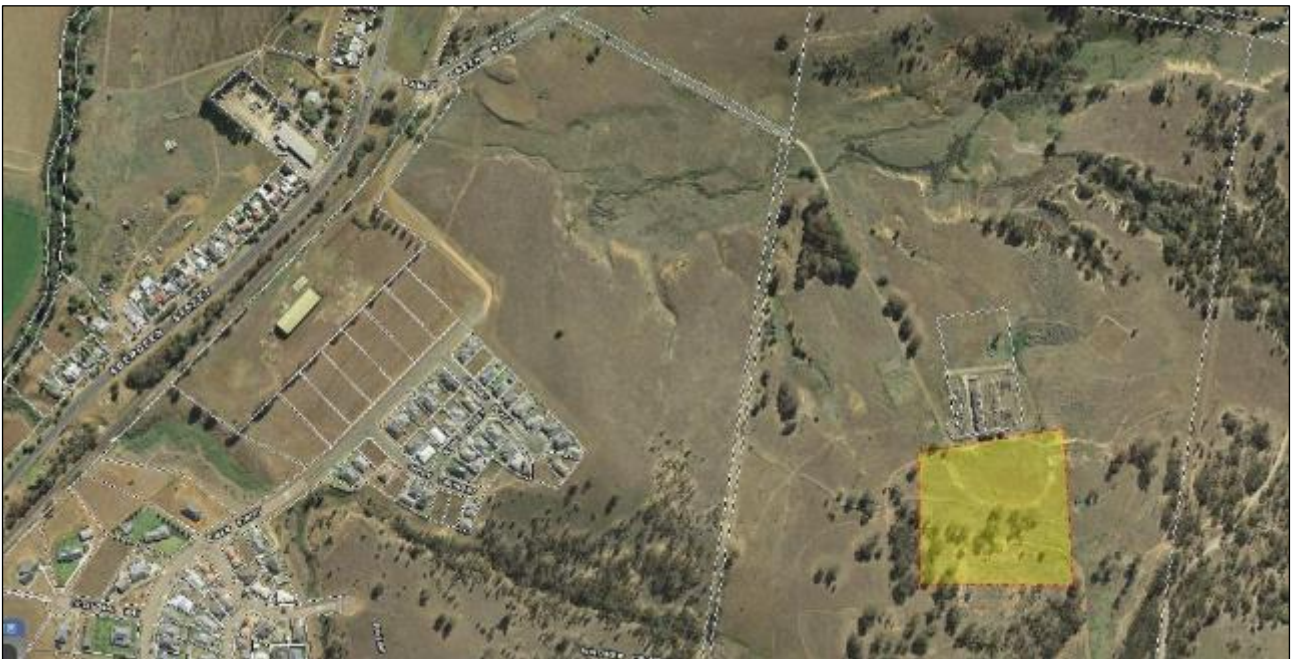
The investigation area included the northern portion of the current site area, plus an additional area to the north, which was found to be the location of a former small power station. The approximate location of the previous assessment is shown in Figure 3.

**Figure 3: Approximate location of former investigation area (yellow)**

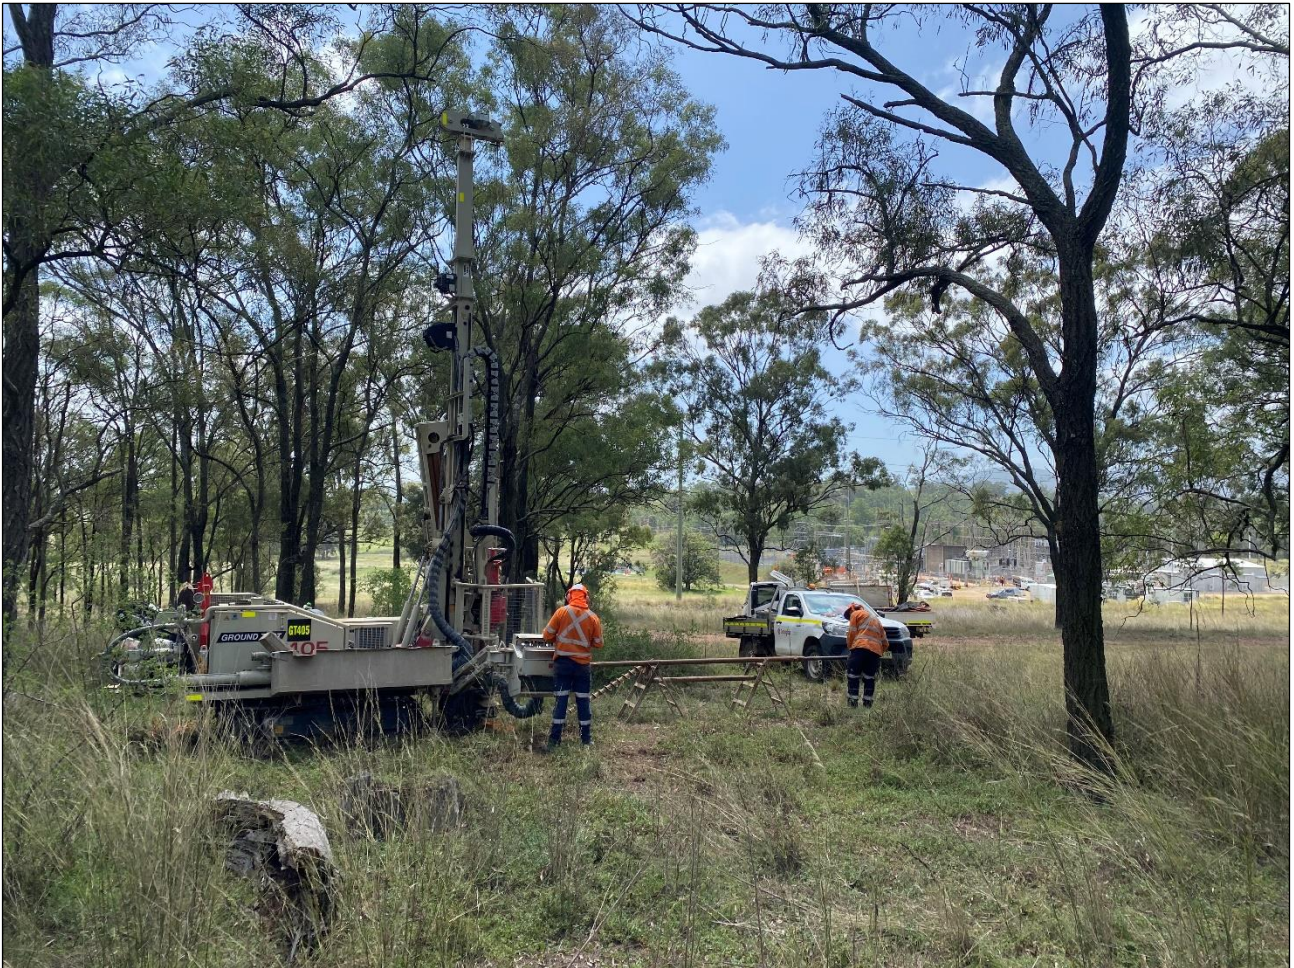
**Photograph F1: looking north-east from the western portion of the site, with the site falling to the north (existing substation in background)**

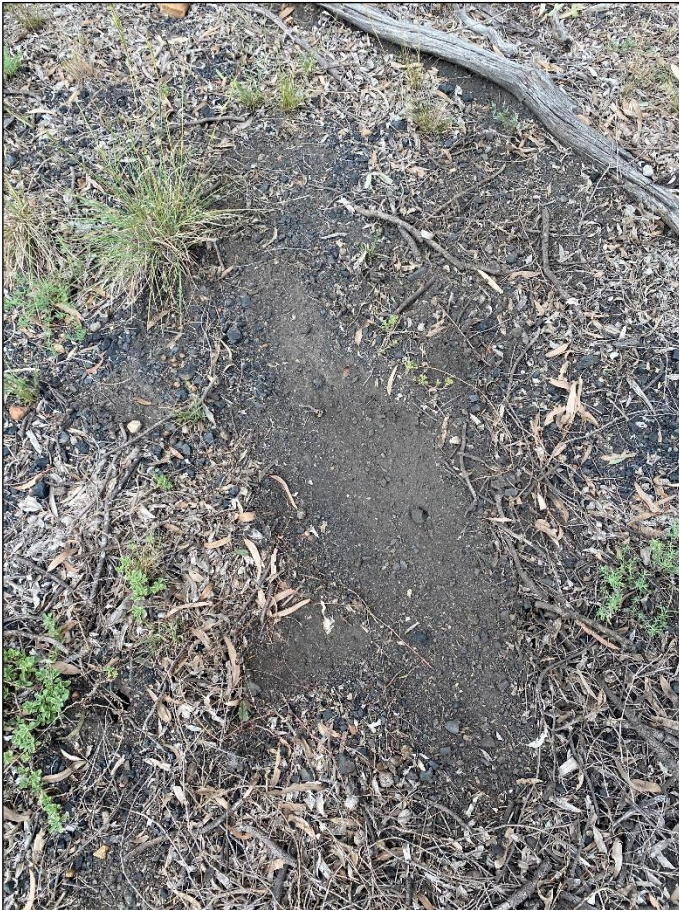
**Photograph F2: Possible ash and coal gravel at the site surface, generally in the eastern portion of the site**

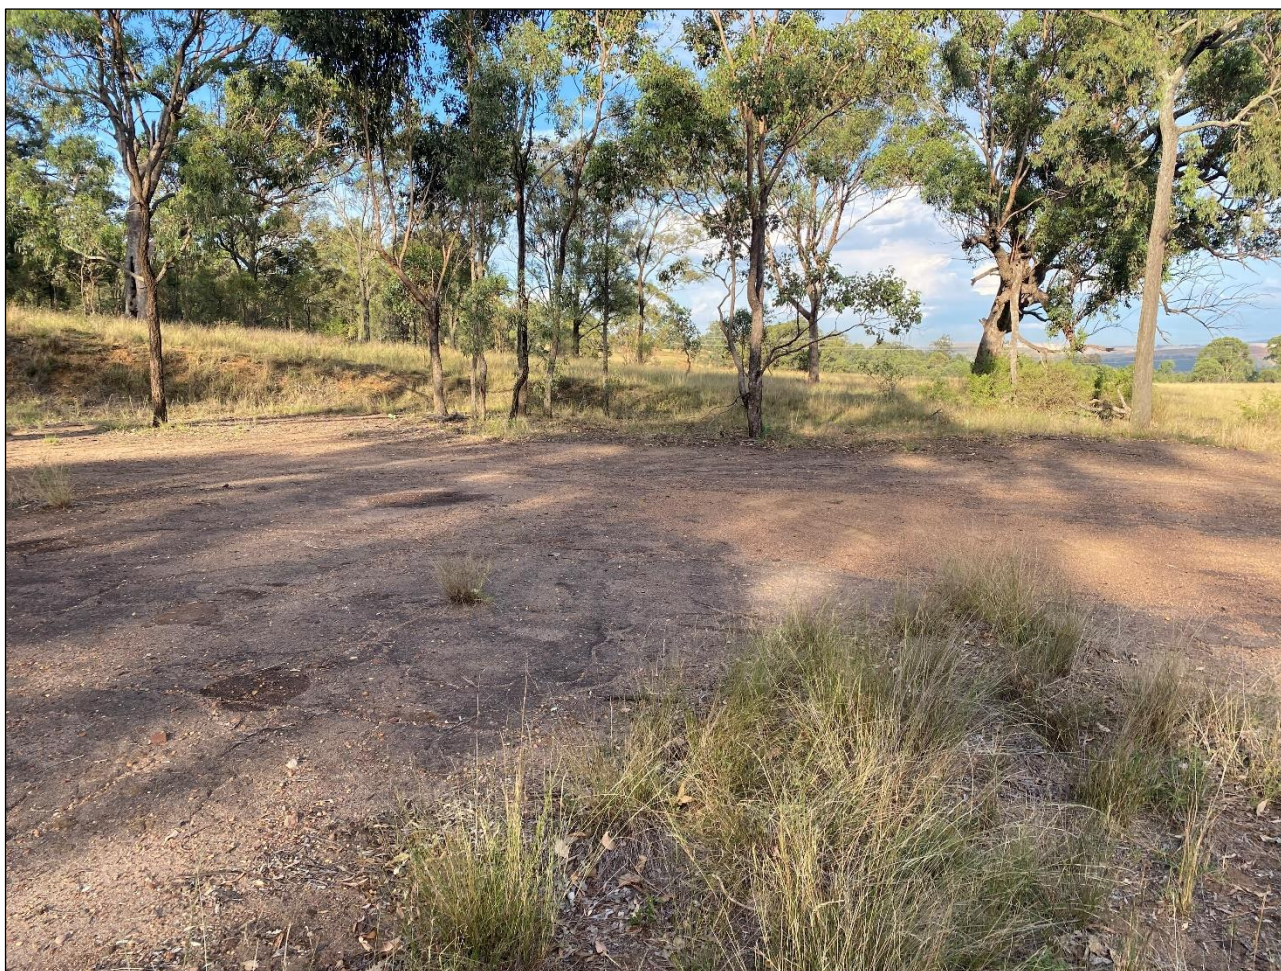
**Photograph F3: levelled area in the southern portion of the site, looking west**

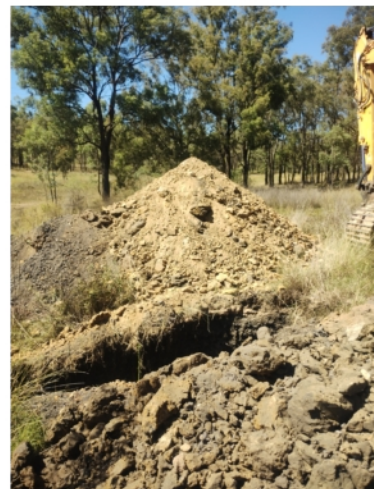
Spoil from Pit 314

| CONDITIONS ENCOUNTERED | | | | | | SAMPLE | | | TESTING AND REMARKS | |
|---|---|---|---|---|---|---|---|---|---|---|
| | 4 | Test Pit discontinued at 4.10m depth. Pit wall collapse, no solid rock encountered. | | | | | | | | |
