ASP Safety Alert

Alert Number: SA14_17

Subject: Steel Framed Pillars - Requirements of NS199

29 November 2017

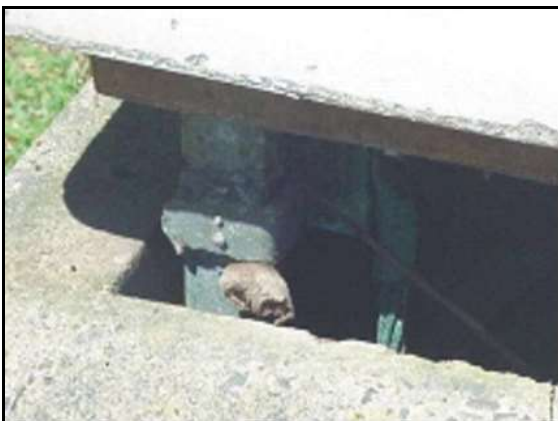
These pillars are usually identified by a concrete base, fibreglass turret and the longest side of the (rectangular) pillar aligned parallel to the front property boundary.

Should you be unsure if the pillar is steel framed, the turret may be lifted with caution to a maximum of 50mm, whilst wearing appropriate PPE, to check for the presence of a steel frame (Refer Fig1). If a steel frame is detected, the pillar turret must be lowered and secured immediately and contact made with Ausgrid to arrange for an outage to conduct the work.

Figure 1 – Typical steel framed pillar (lower Hunter region) (including 50mm opening, for steel frame detection)

These pillars must not be opened whilst energised, due to the risk of flashover on opening.

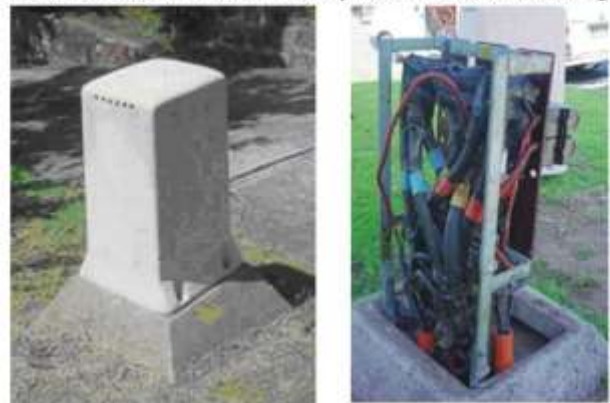
NS199 – Clause 9.3.7 - Steel framed pillars in the lower Hunter region

NS199 – Clause 9.3.7 – Steel framed pillars in the lower hunter region
