# ASP Safety Alert

**Alert Number: SA09\_18**

**Subject: Correct procedure for windowing and cutting conduits**

28 June 2018

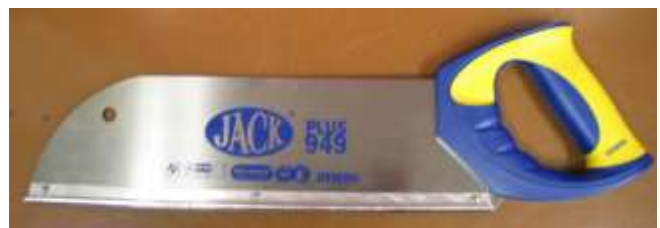
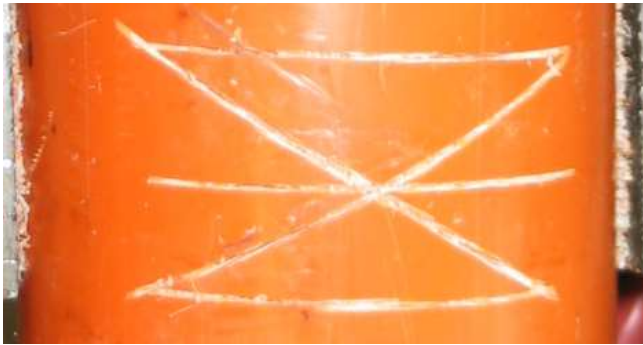
To cut inspection windows into HD PVC conduits, a *depth guided veneer saw* must be used. The depth guide is pre-set at 3mm by the manufacturer to ensure that inadvertent contact with any assets located within the conduits cannot occur.

Using the *depth guided veneer saw*, make 3 parallel cuts concentrically across the conduit to the depth governed by the depth gauge. The spacing and length of these cuts will determine the final size of the inspection window. Following the parallel cuts, cut an X between the two outside lines.

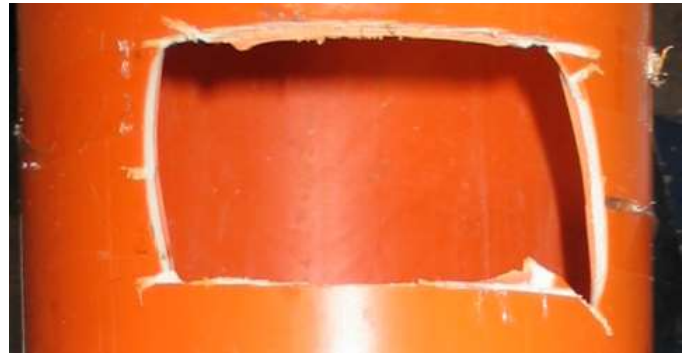
Use a ball pein hammer to strike the centre of the X until a rectangular section of the conduit breaks away resulting in an inspection window.

Note: The location of the inspection window should be in the section of conduit to be cut out and abandoned

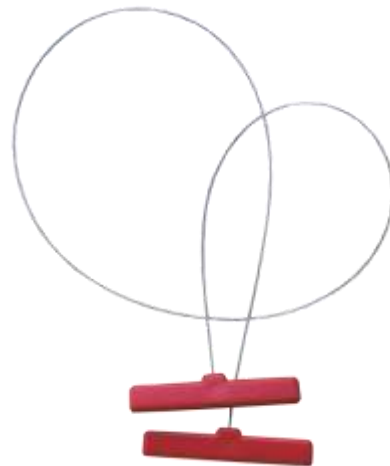
Once conduits have been positively identified to be clear of any assets, a *cable saw* must be used to complete the final cutting of electrical conduits.

Care must be taken when using a *cable saw* to ensure that inadvertent contact is not made with any surrounding assets.

**Powered cutting saws of any type are not to be used on or near the Ausgrid network under any circumstance**
