ASP Safety Alert

Alert Number: SA06_17

Subject: CLIPSO brand – Service / Meter Protection

6 July 2017

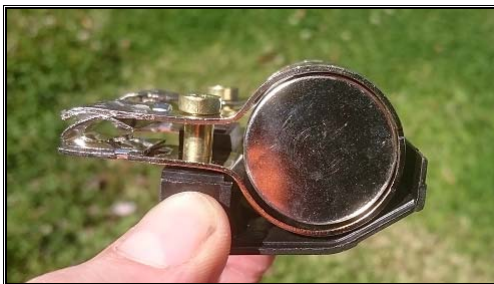
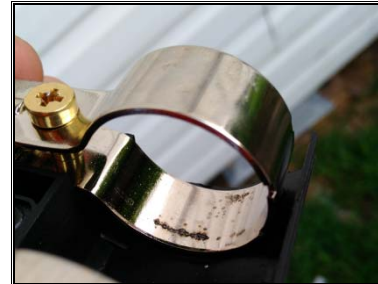
Ausgrid has become aware of a hazard associated with the high resistance connection of CLIPSO HRC fuse links (within fuse carriers). In response to a customer report of no supply / part supply and voltage fluctuations, Ausgrid has identified a defective panel mounted service / meter protection device. Specifically, the ring, which clamps around the barrel of the HRC fuselink, is slightly too large in diameter for the fuselink when fully tightened. This has created an ineffective electrical connection which resulted in arcing between the fuselink and the ring clamp (see photographs below).

The potential could arise for damage to appliances, overheating and, in a worst case, the possibility of a switchboard fire.

ASPs who, during the course of their work, identify a CLIPSO brand of service / meter protection device within a customer's electrical installation, should dismantle the fuse carrier to verify the fuselink is fixed securely in place with no movement. If this cannot be achieved, and to mitigate any electrical risk, supply should be disconnected, and the defective parts replaced before supply can be reinstated. If the ASP cannot perform this work then the customer can engage Ausgrid, for a fee, to perform this work.
