ASP Safety Alert Network Compliance and Authorisations

Alert Number: SA19_19

Subject: Pole failure caused by change of pole loading

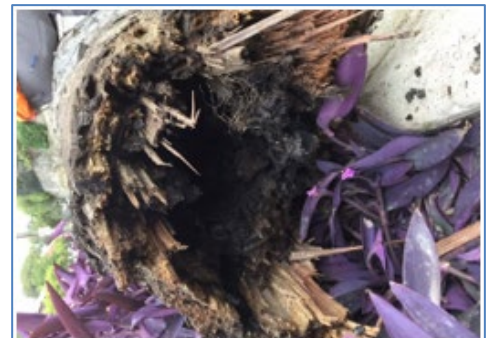
To assist in staging the scope of works, an ASP1 changed the construction on a pole from a straight-through to a termination construction and removed the conductors from one side of the pole. Approximately two weeks after these changes were made the pole failed and fell to the ground. On inspection, significant rot was observed in the base of the pole. Fortunately, no persons were injured as a result of this incident.

Figure 1: Internal pole decay

The type of work being carried out on a pole is indicative of the stress that will be placed on the pole. Information on stresses that can be applied to poles due to loading or altering the load on a pole can be found in NS146 clause 4.4.

Most other types of work or alterations, e.g. linework from a platform or change of construction type, could stress a pole sufficiently that the pole may fail if in a weakened condition and therefore must be dug out and inspected accordingly.

ASPs to communicate to all authorised employees, supervisors and project managers the requirements when existing pole loadings are intended to be altered.

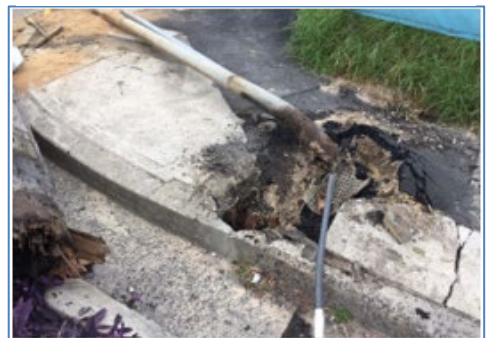
Figure 2: Original pole location
